## River Pinn & Ruislip Woods

# Flooding Issues – Does the Geology have an influence?

Report of a site meeting on  
24 November 2021

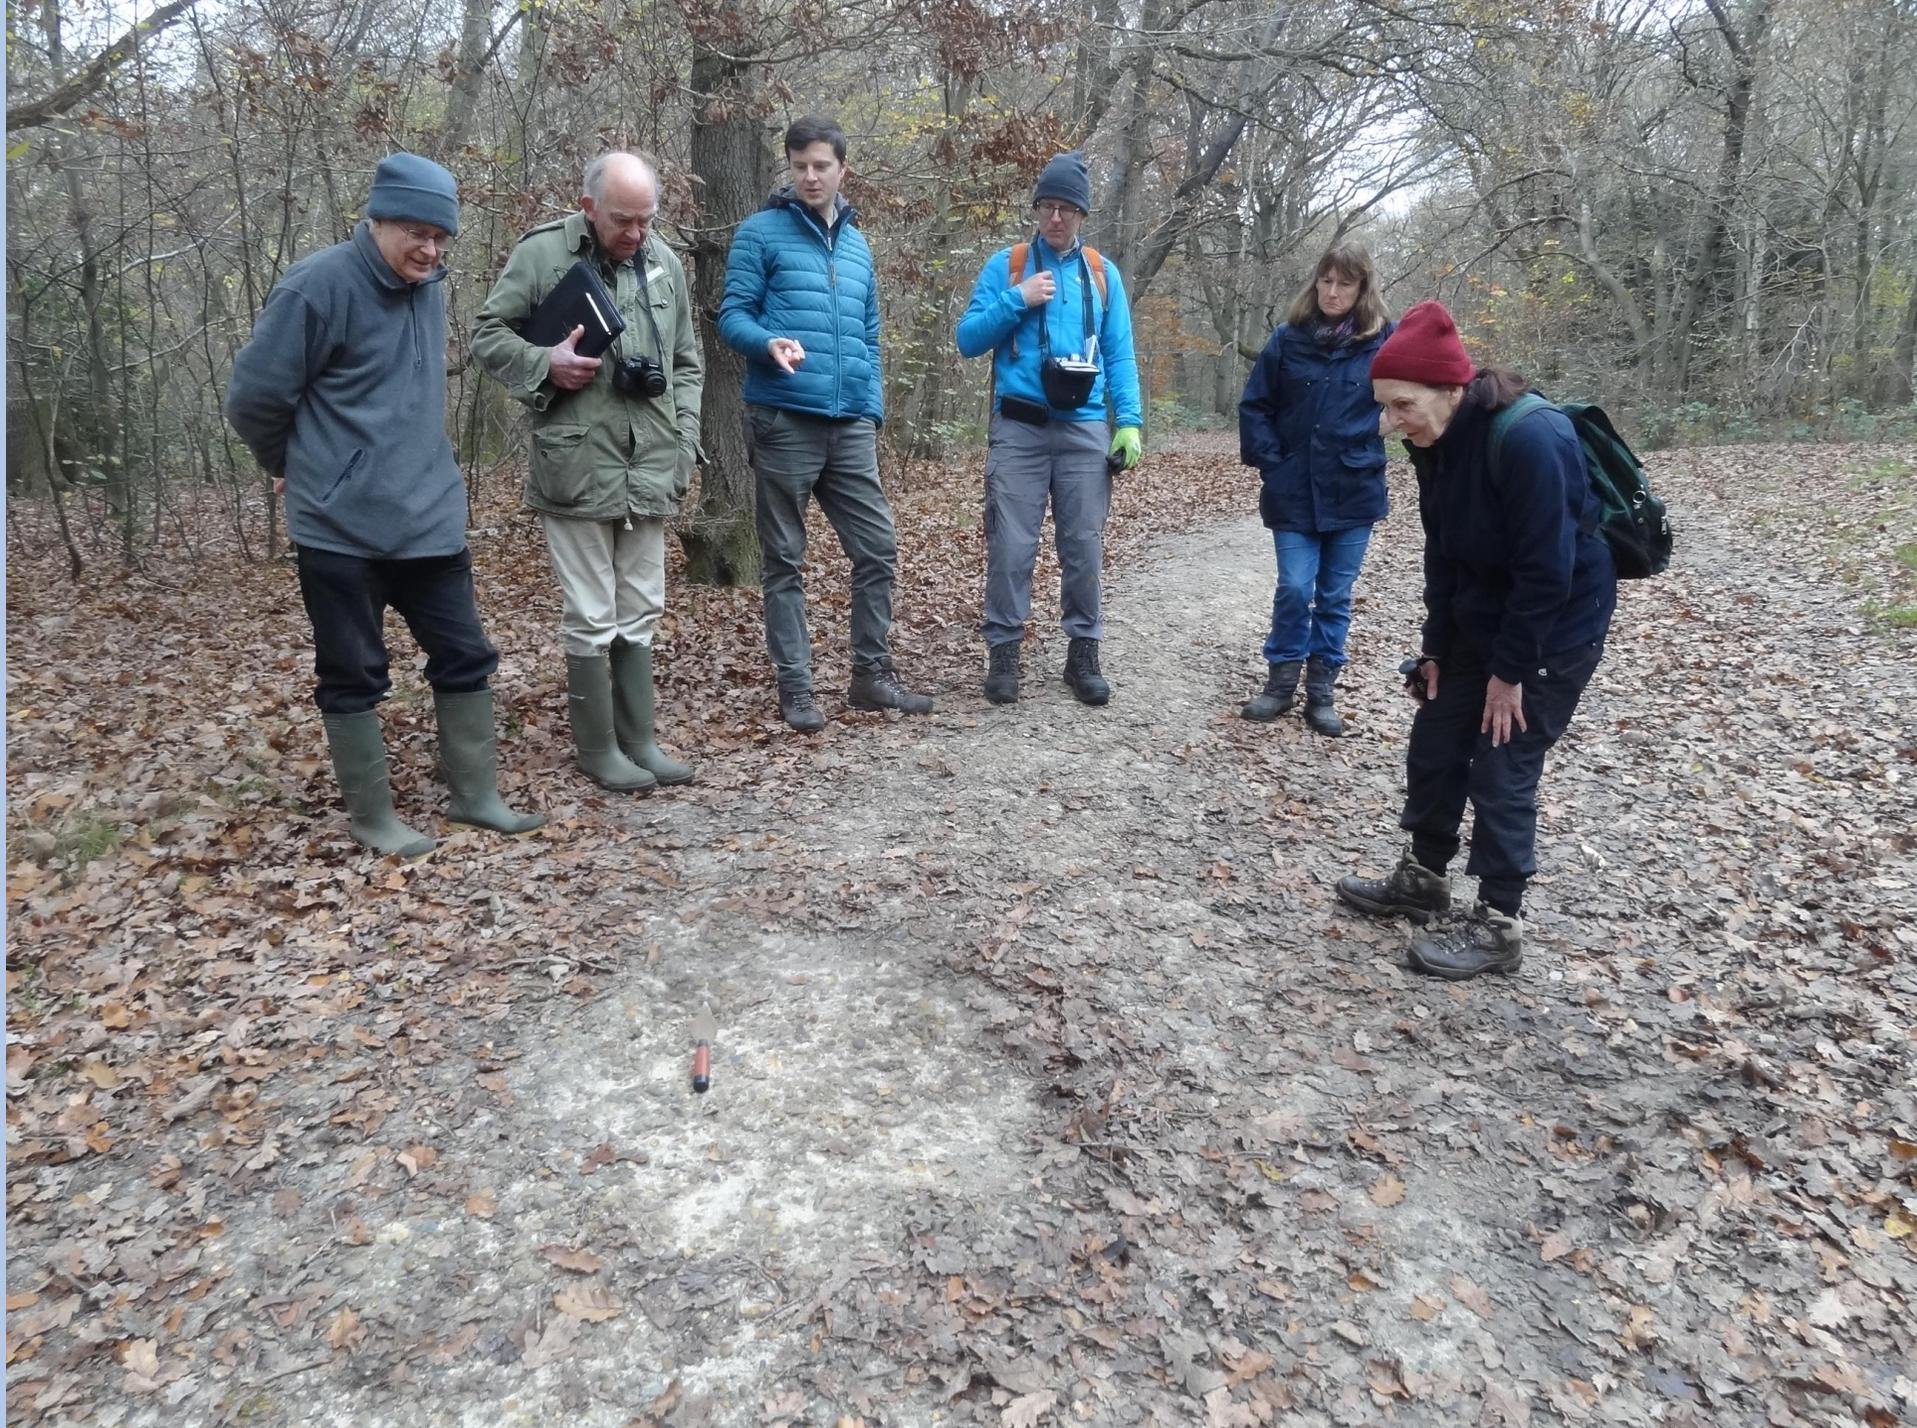
**Park Wood –  
gravel surface**  
with impermeable  
matrix (sandy clay)

Considered partly  
responsible for  
increased run-off  
from the woodland  
into properties and  
Pinn Meadows.

The extent of the  
gravel is to be  
determined.

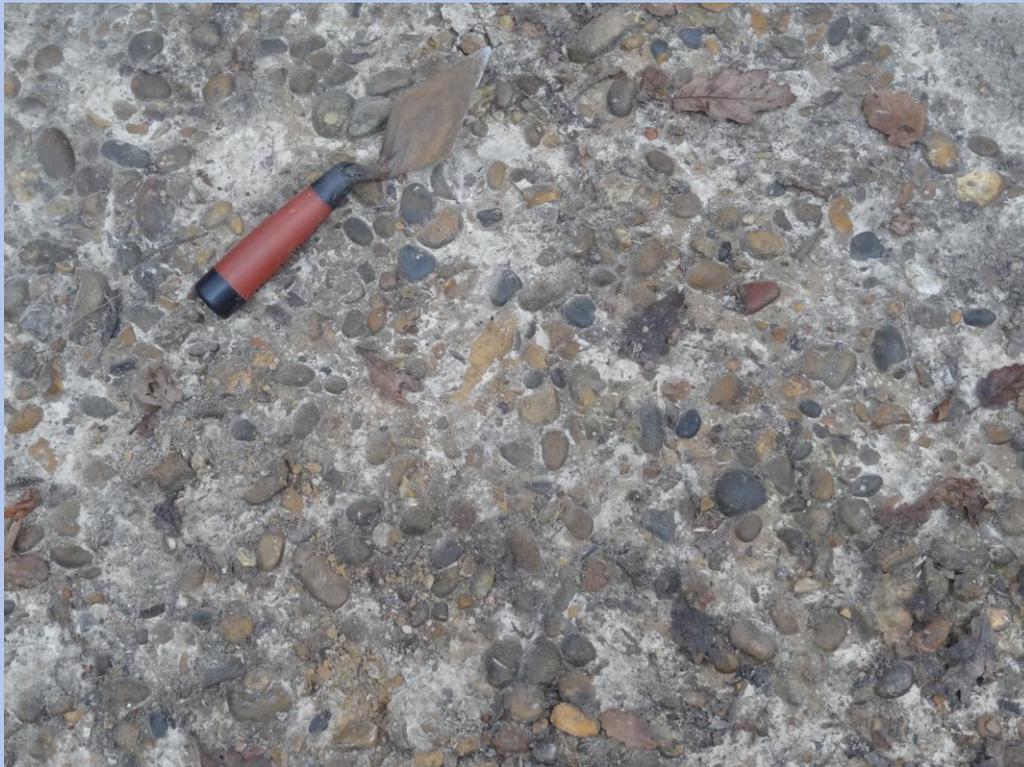
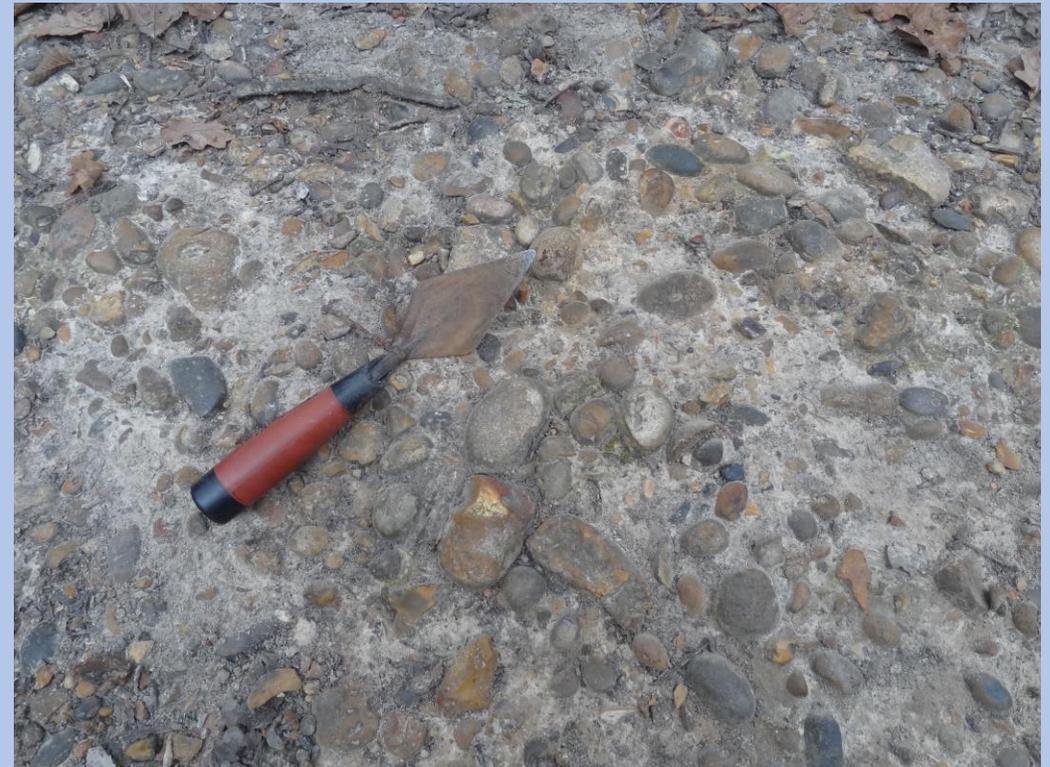
The pebbles are in a matrix of firm sandy clay and are mainly of flint.

It is unclear whether the gravel is a superficial deposit or is part of the bedrock.

The trowel is 23.5 cm long

Mapping and clast analysis may help establish where the gravel belongs.

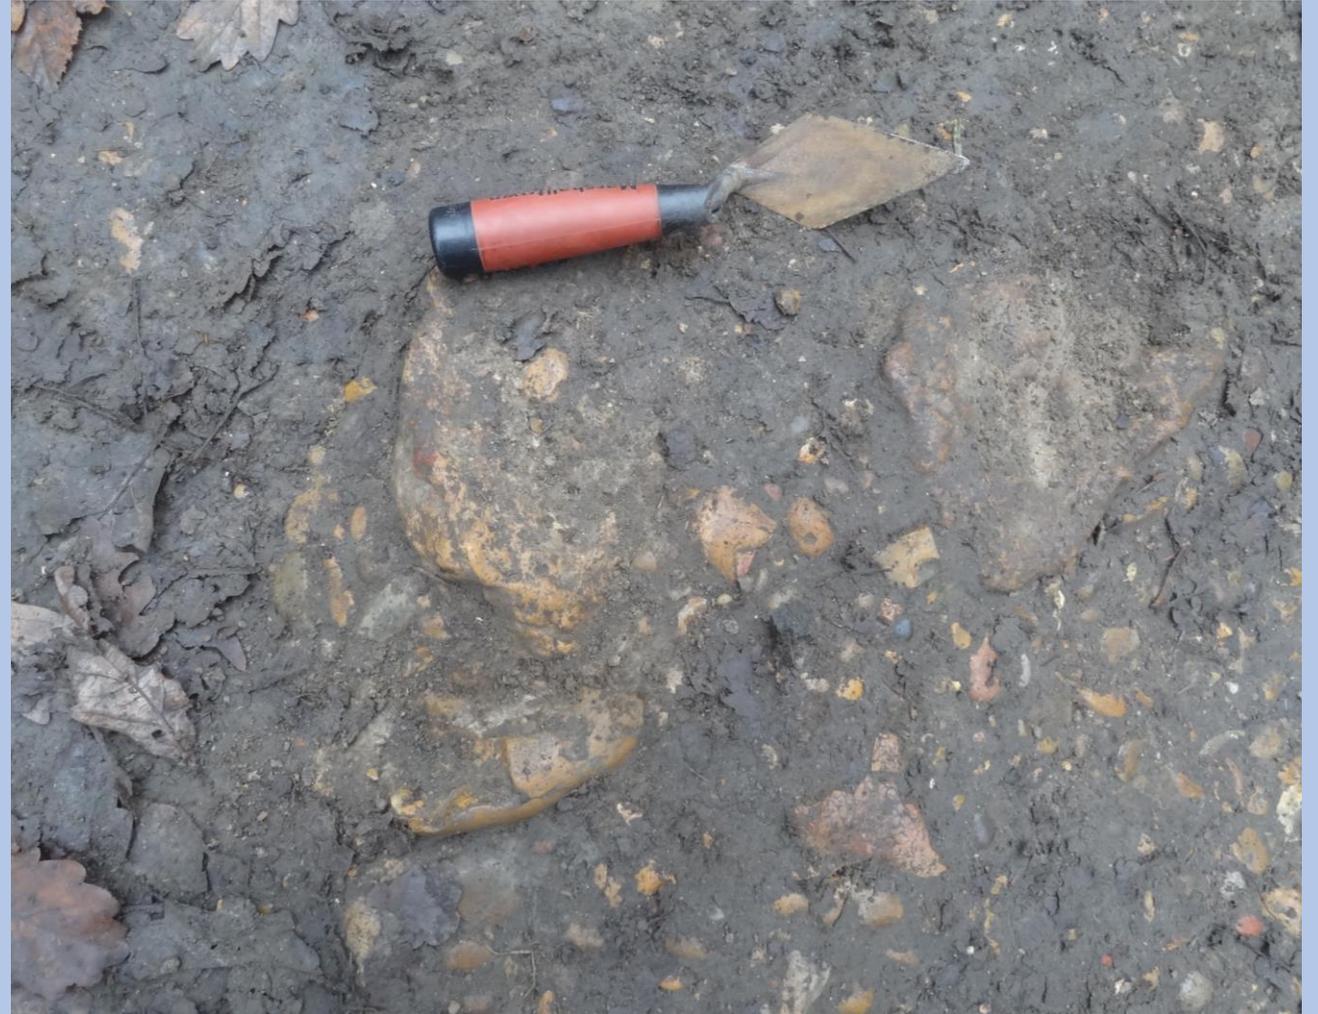
This view shows a group of much larger clasts – sarsen?

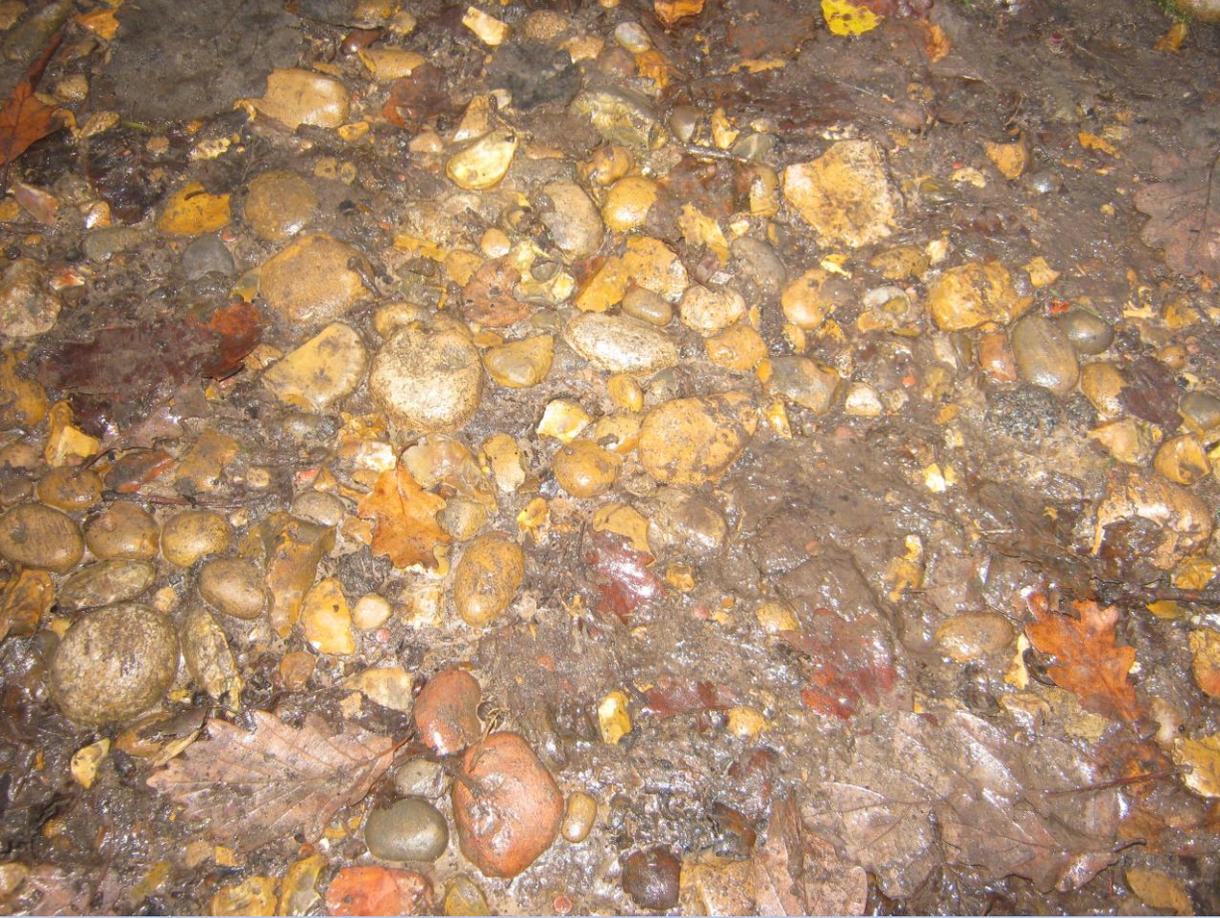
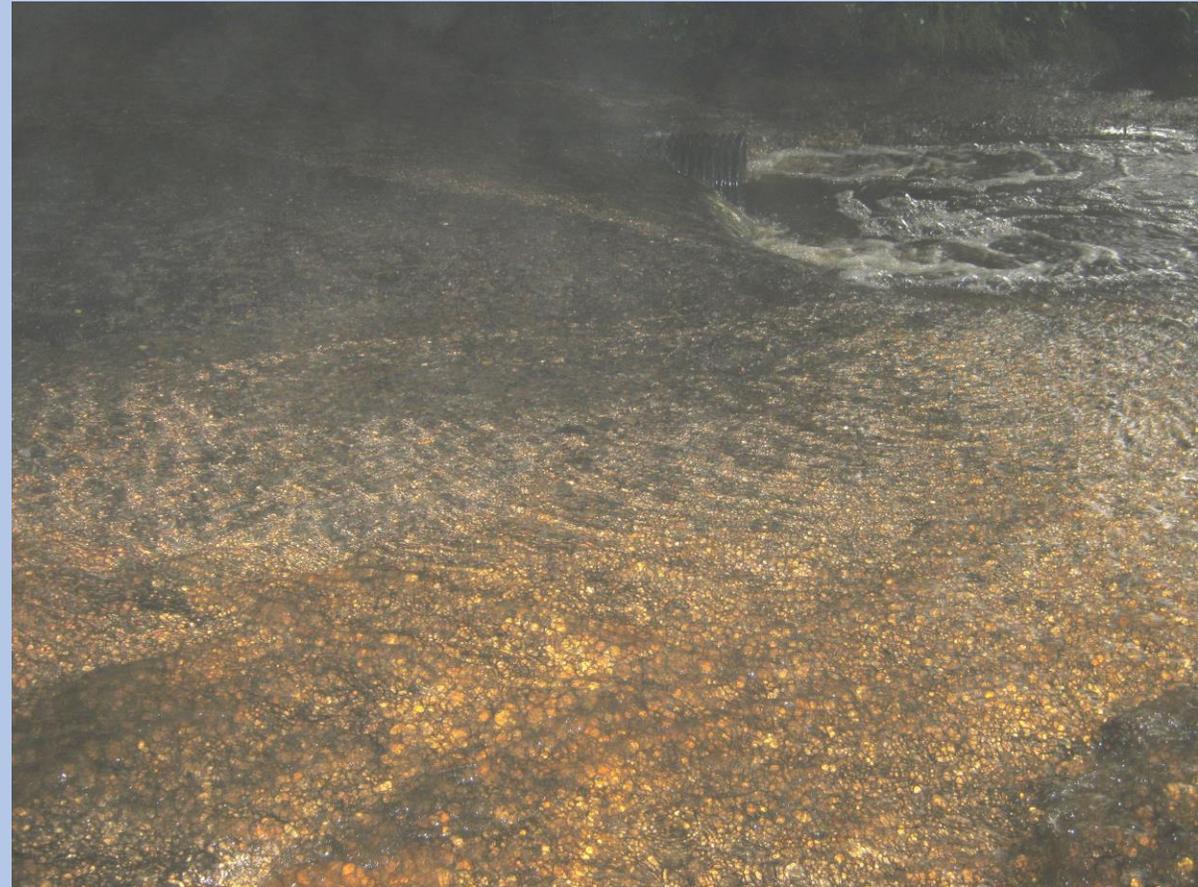
# Park Wood gravel in flood conditions following a summer storm

The storms affected much of the London area that day.

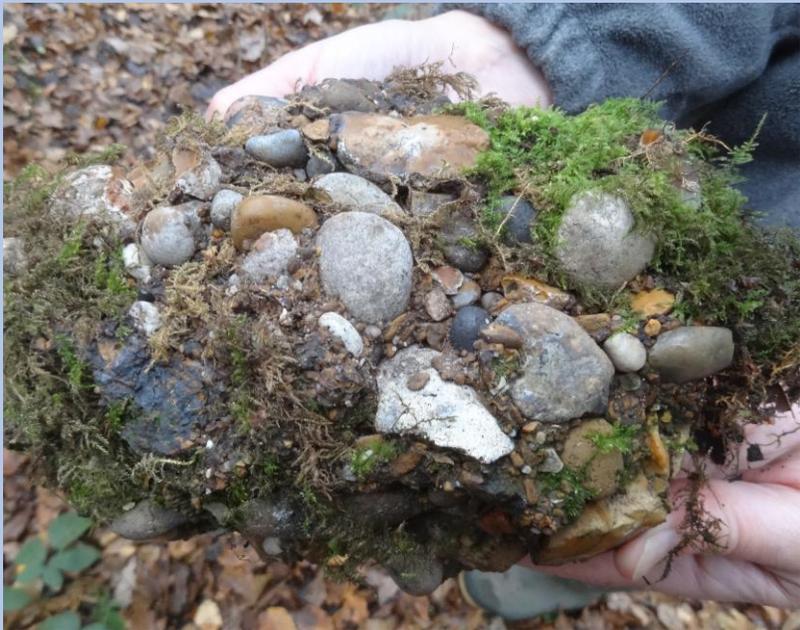
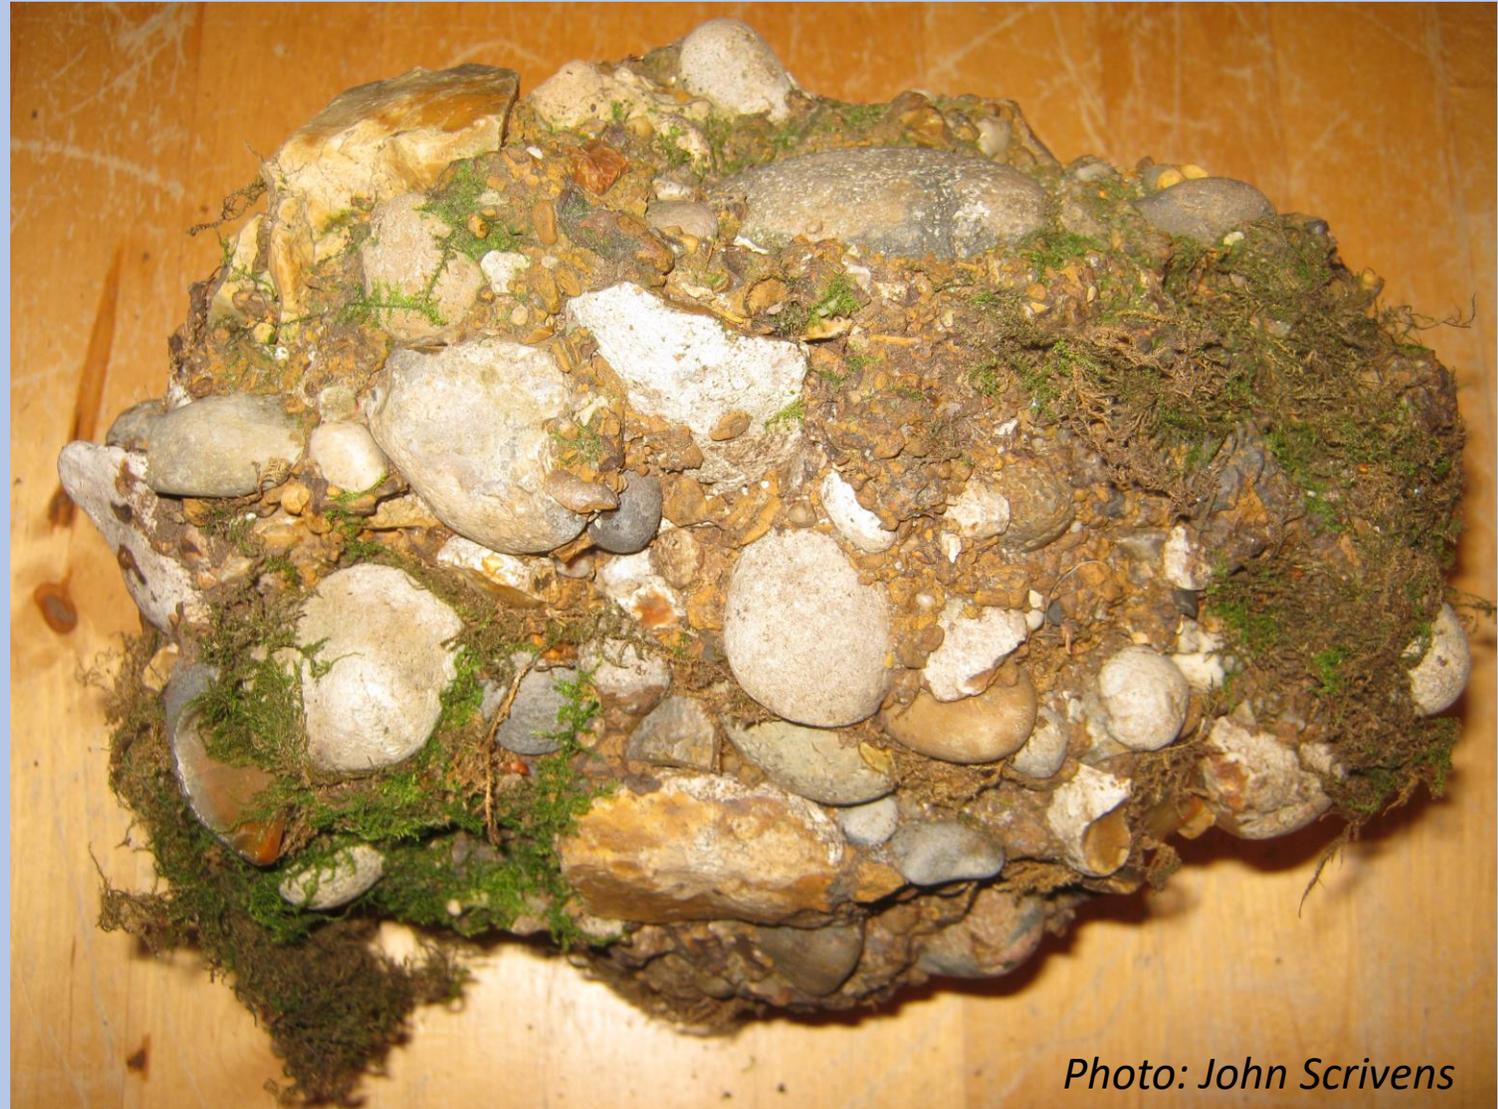
# Block of cemented gravel found close to the Coppicers' Channel

It's most likely to be **ferricrete** (i.e., cemented by iron oxide)

Found in Park Wood near the main footpath from Broadwood Avenue.

The matrix consists of sharp sand to small gravel.

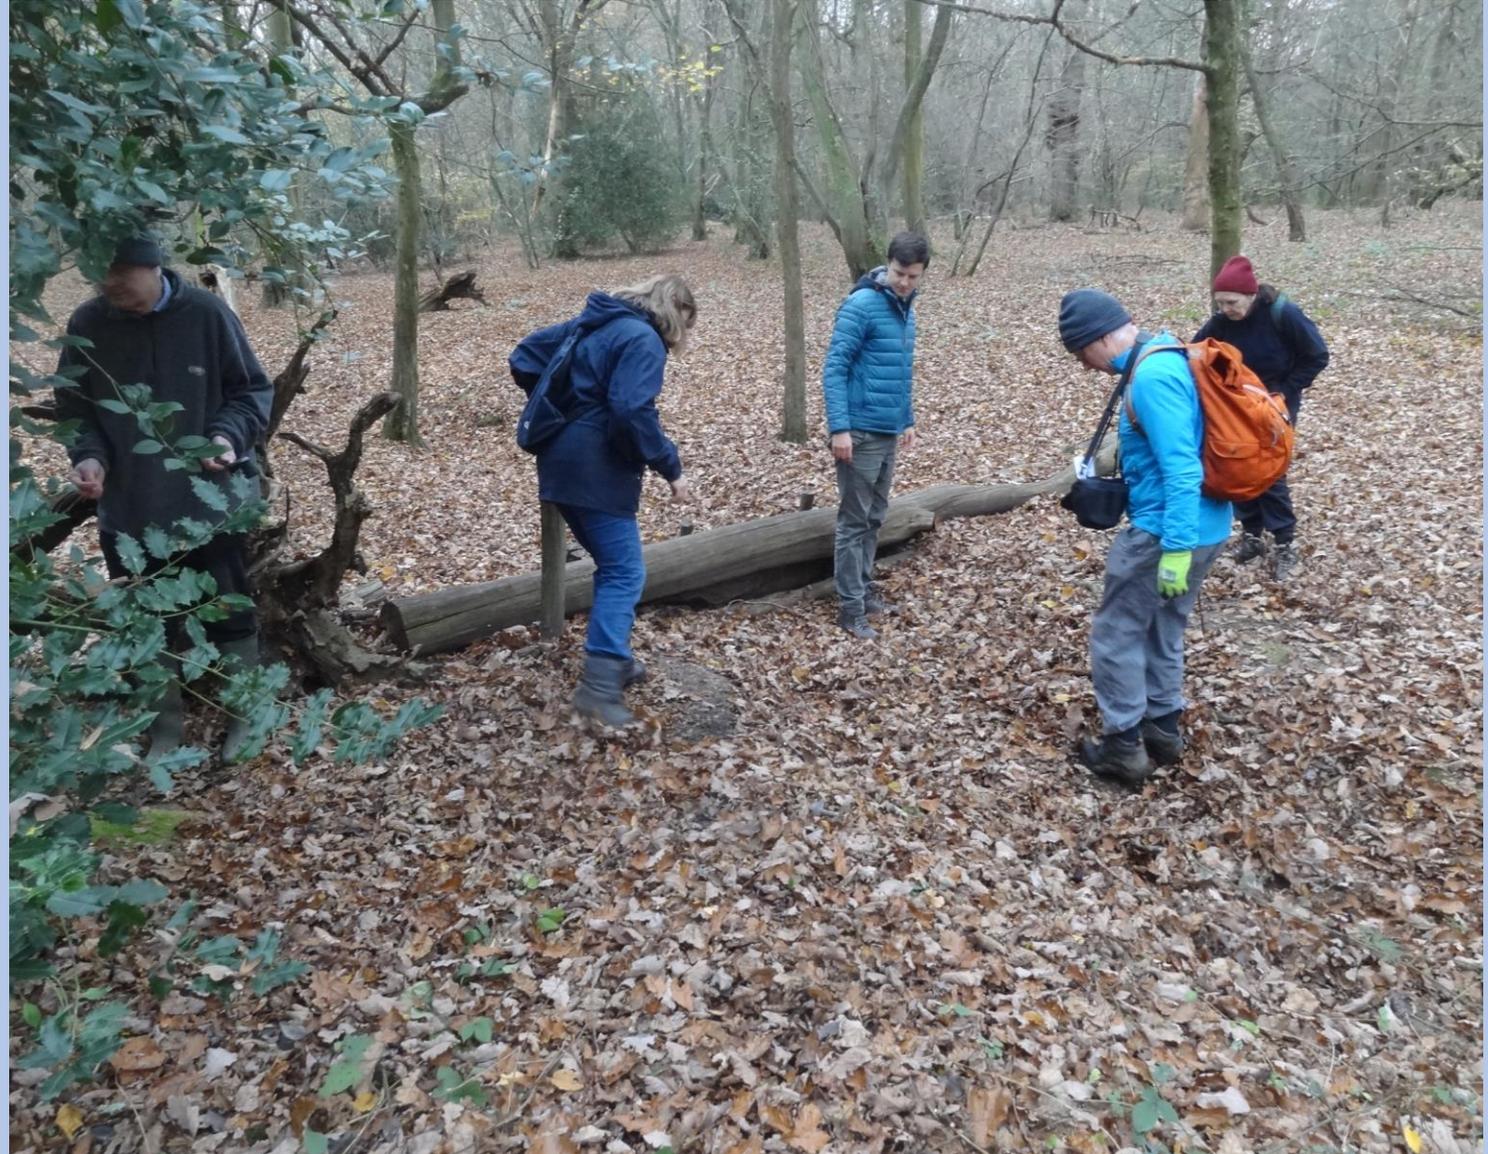
# Coppicers' Channel (dry)

Section looking E about 50m E  
of the main footpath from  
Broadwood Avenue.

November 2021 was much  
drier than average with only  
8.5mm of rain at Northolt  
(normally 67mm).

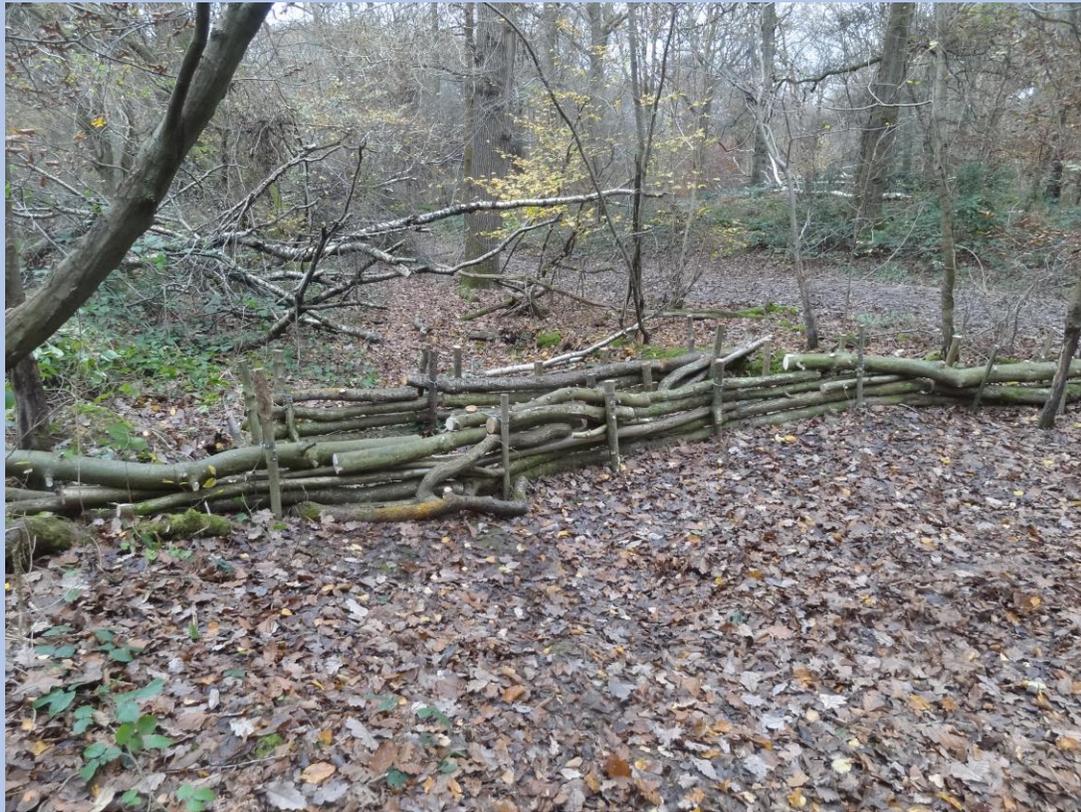
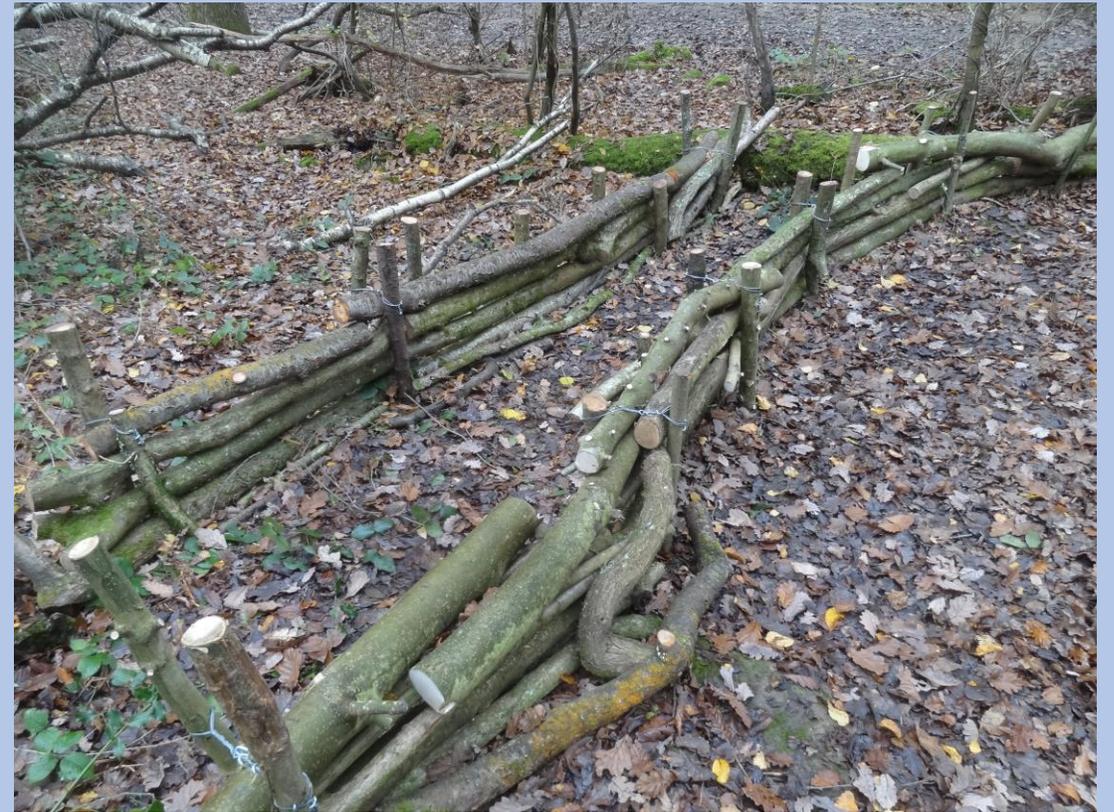
# Leaky dam, Park Wood

This has been built across a tributary of the Coppickers' Channel. It is designed to reduce the downstream flood peak by temporarily storing water by holding it back within the stream's channel or encouraging it to spill onto the banks behind the barrier and thus slow the flow.

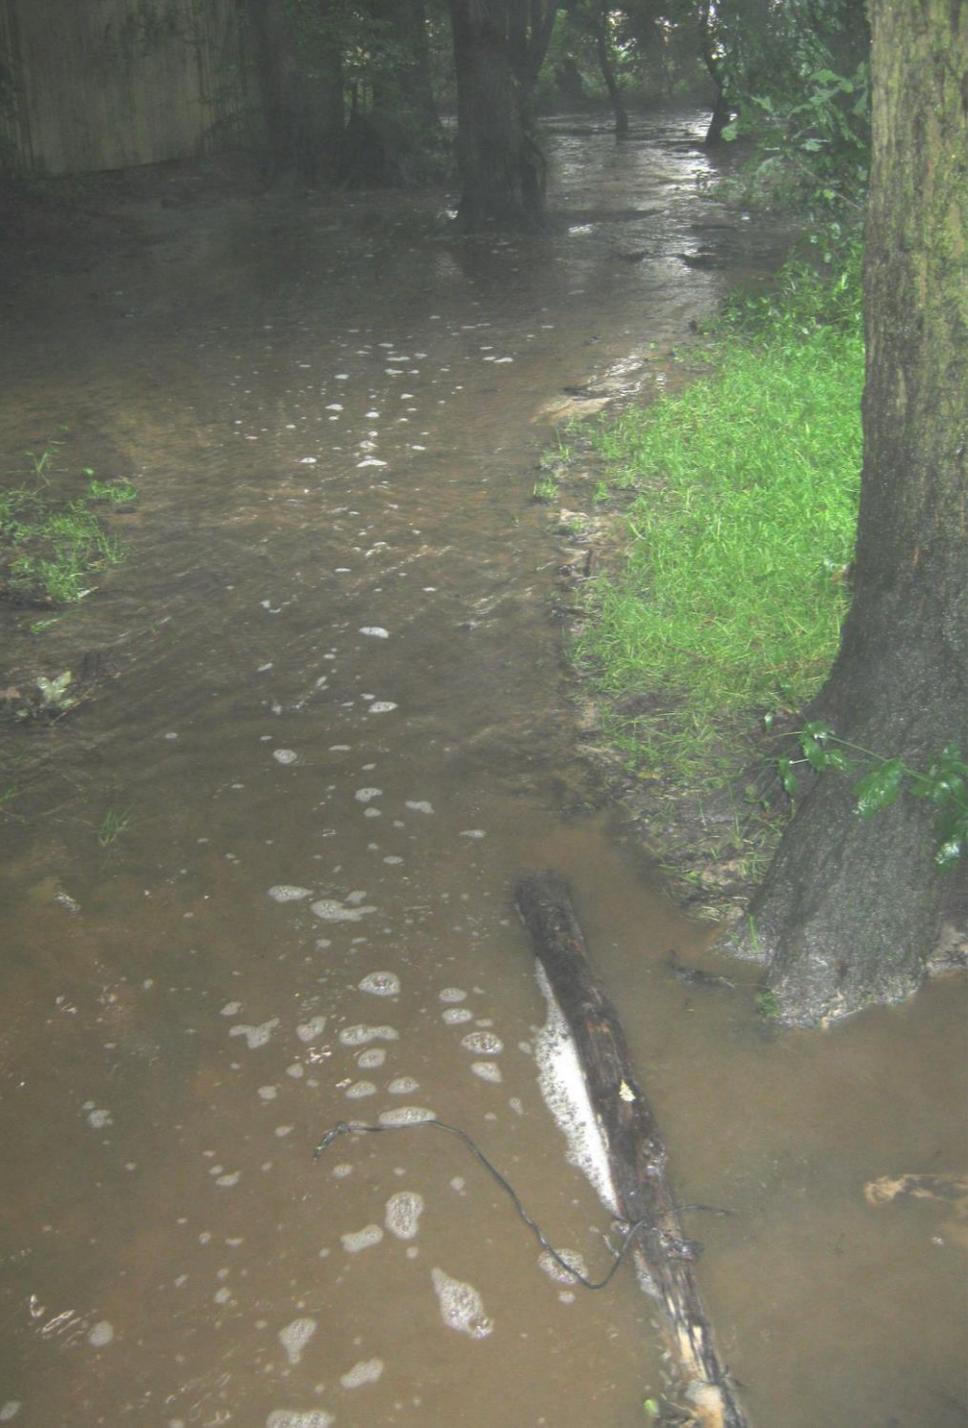
However, as mentioned, water can also flow along footpaths, such as here after the storm of 23 June 2016.

Several paths have been compacted by high footfall, increasing run-off.

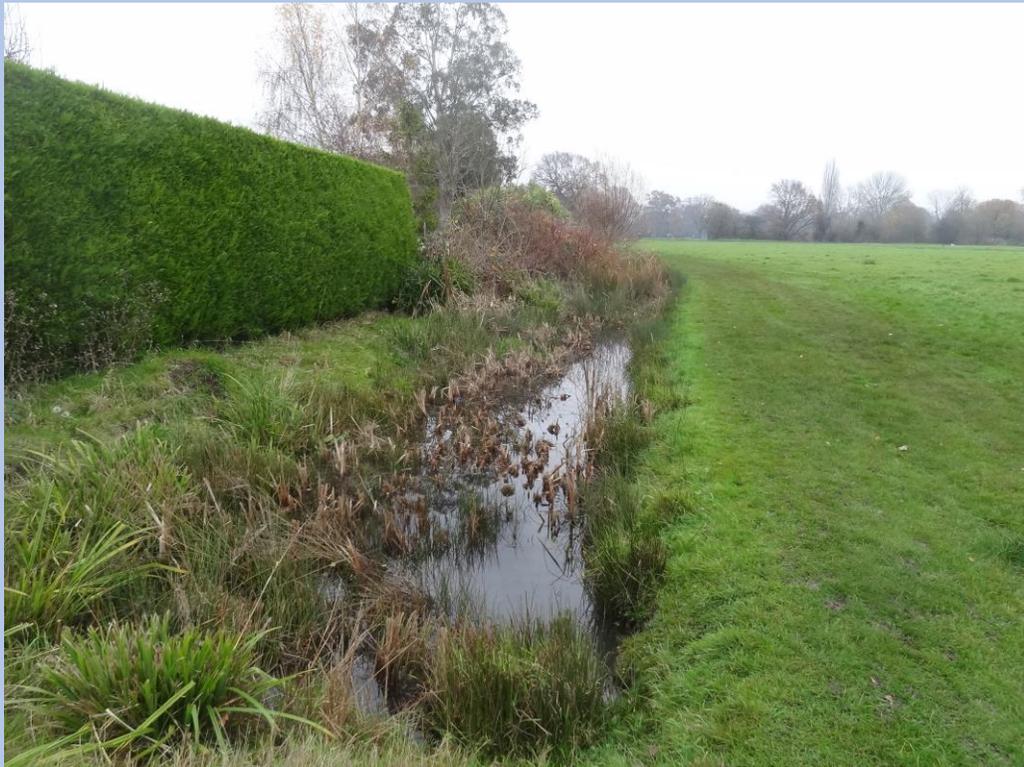
# E-W drainage ditch parallel to Park Avenue

This ditch, alongside back gardens, can overflow after heavy rain. Seen after a dry November.

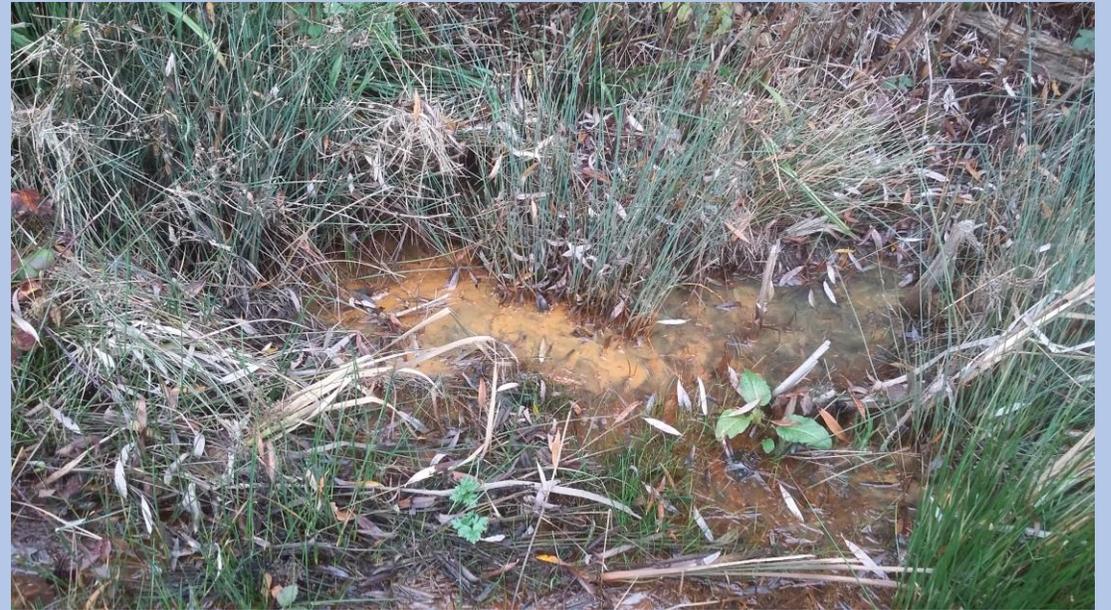
Iron oxide ('chalybeate') staining in the ditch, indicating probable seepage from the Lambeth Group. It occurs only in certain places within the ditch, suggesting spring locations.

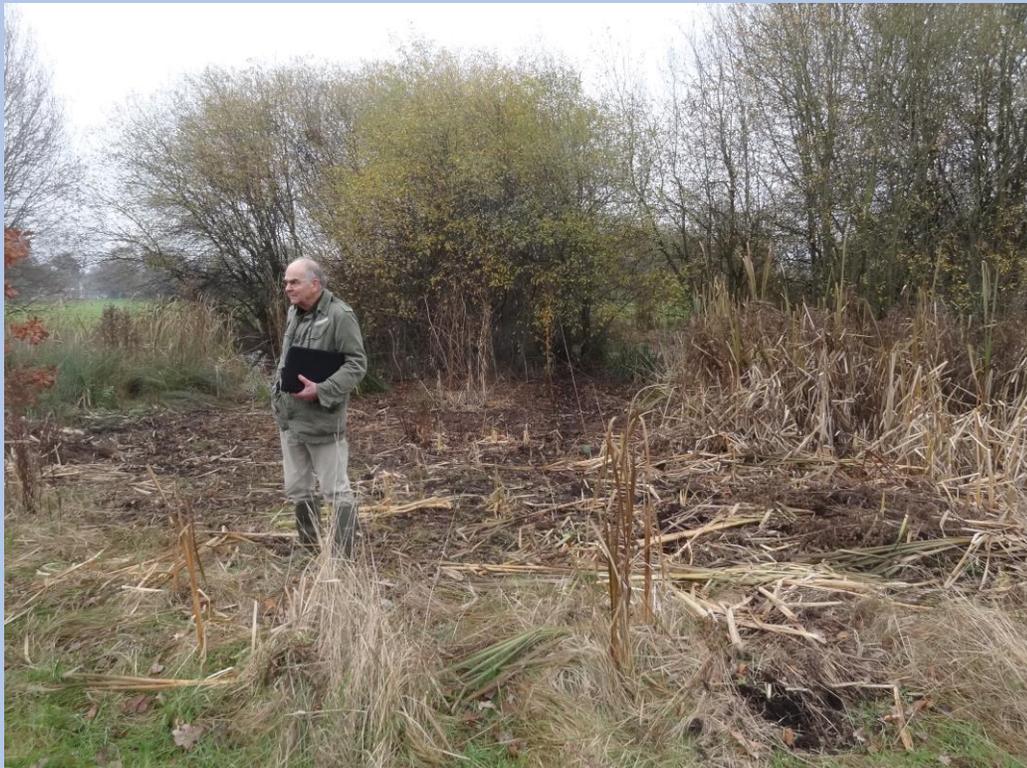
Part of the pond. It is fed by a drainage ditch at right-angles to that in the previous slide.

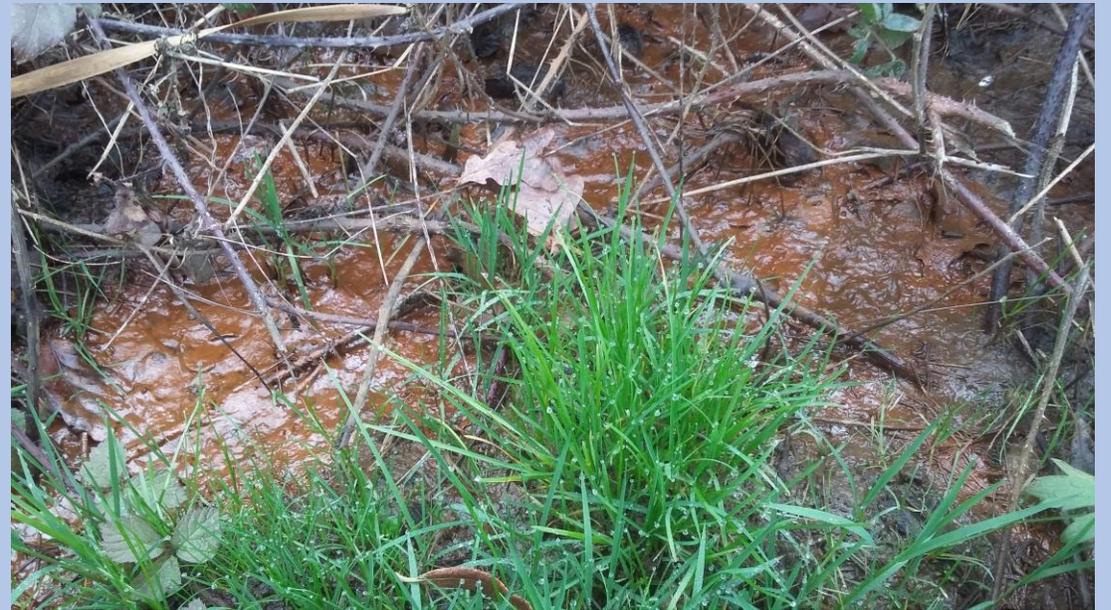
Iron oxide staining in the ditch feeding the pond.

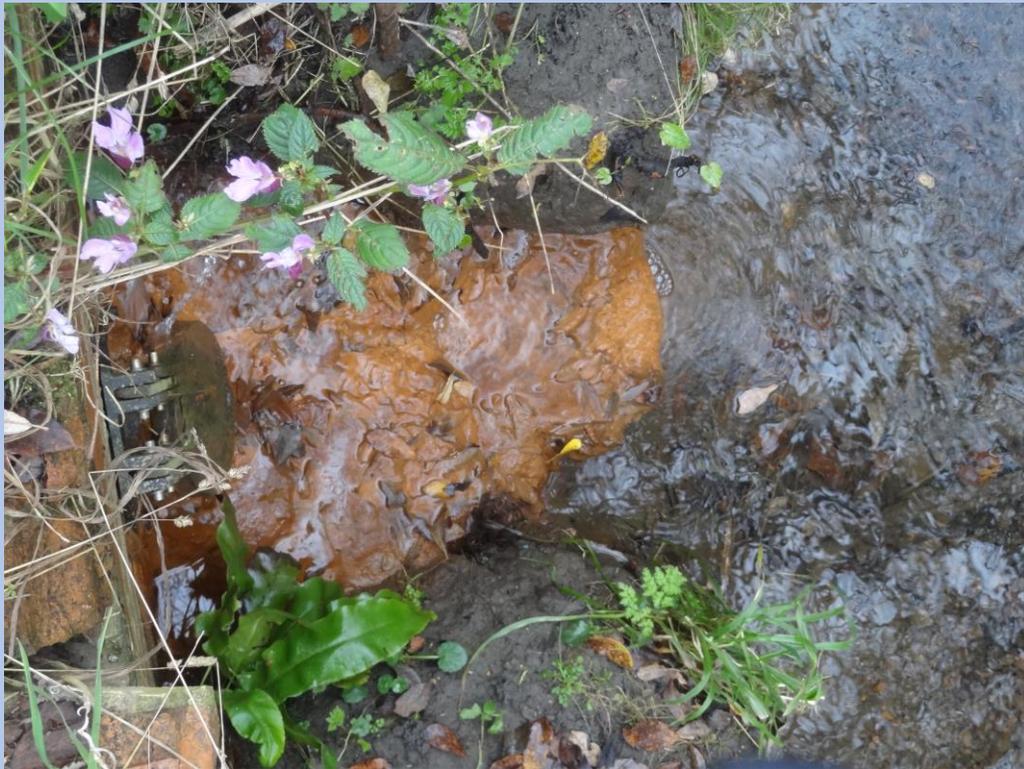
Outflow into the Pinn from the N bank  
c.120m E of St Martin's Approach bridge.

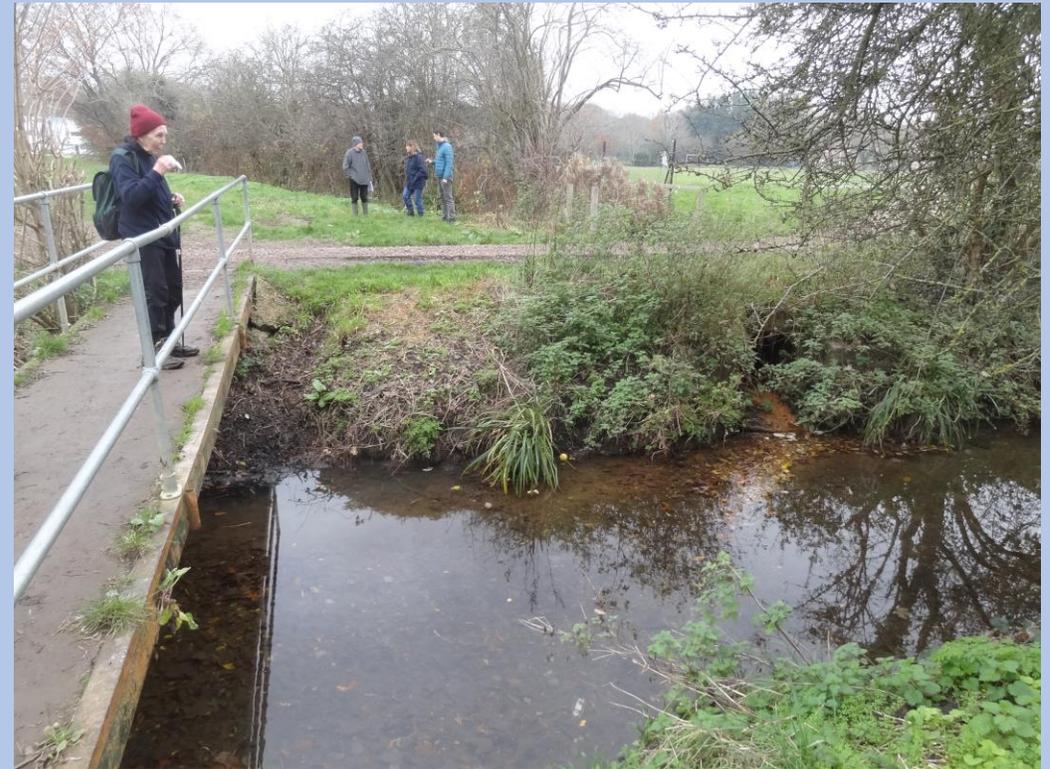
Outflow into the Pinn (N bank) from a tree-lined ditch (Elma's Ditch) in the background.

The ditch connects with the Coppicers' Channel.

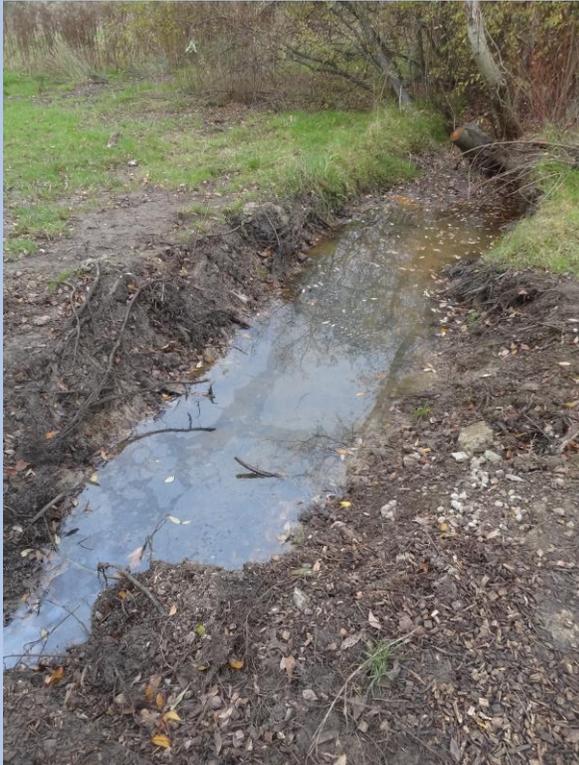
The film is most likely produced by iron-loving bacteria (looking N towards the Pinn).

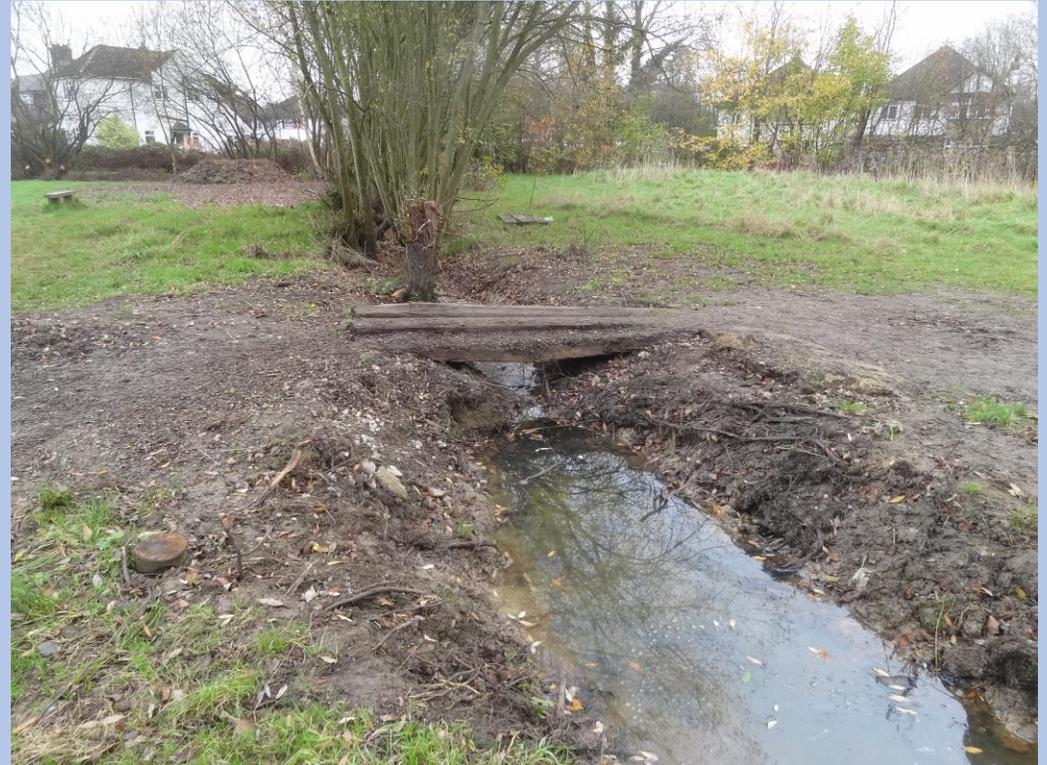
The same ditch looking S. The houses are on Pinn Way and St Martin's Approach.

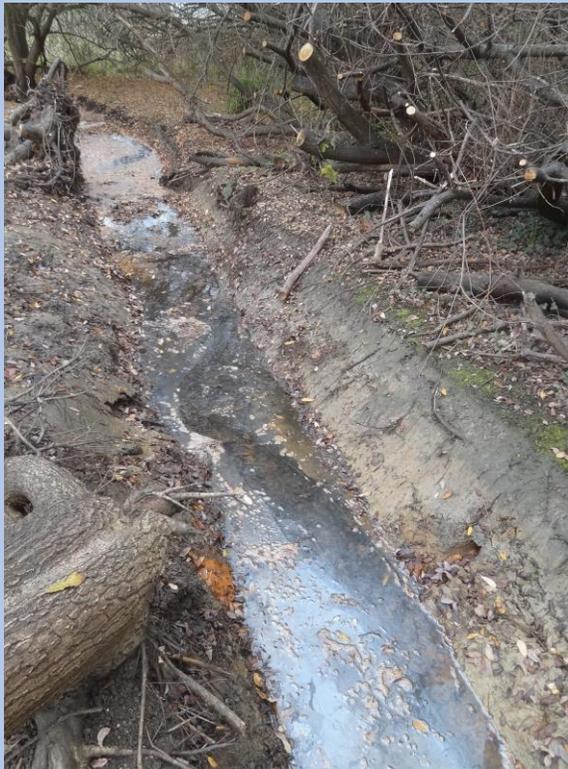
The ditch is on the S bank of the Pinn.  
Bacterial film is again evident.

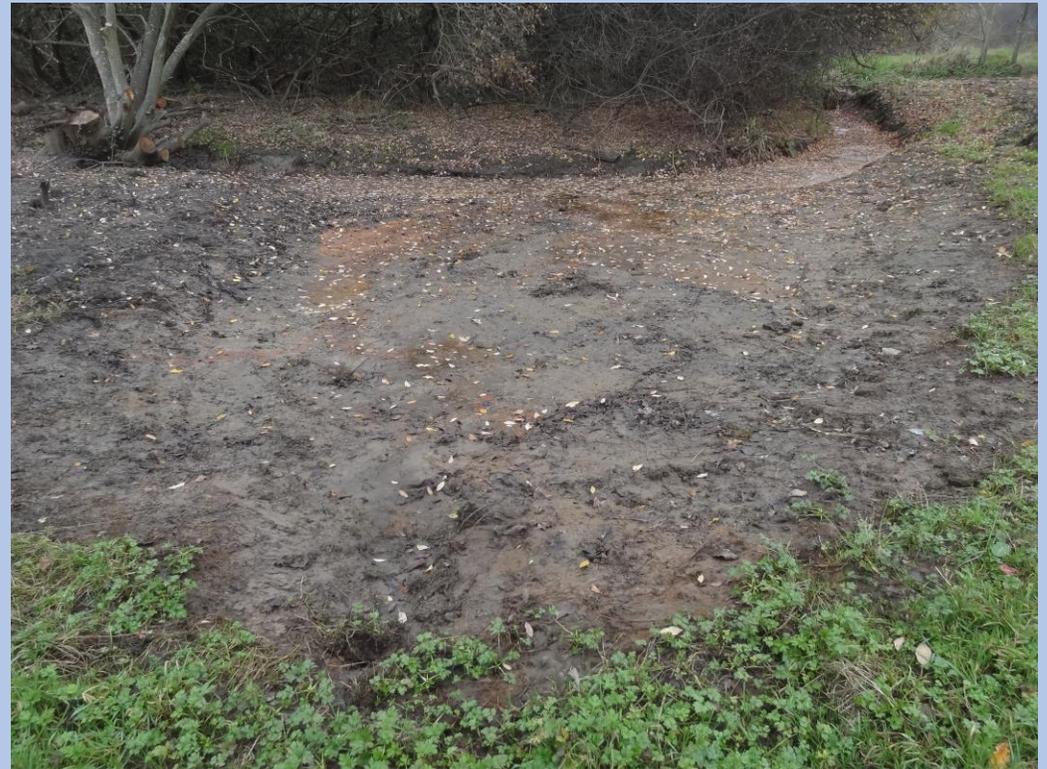
The same ditch looking N. The banks of  
the Pinn are seen top right.
