## River Pinn & Ruislip Woods

# Flooding Issues – Does the Geology have an influence?

Report of a site meeting on  
24 November 2021

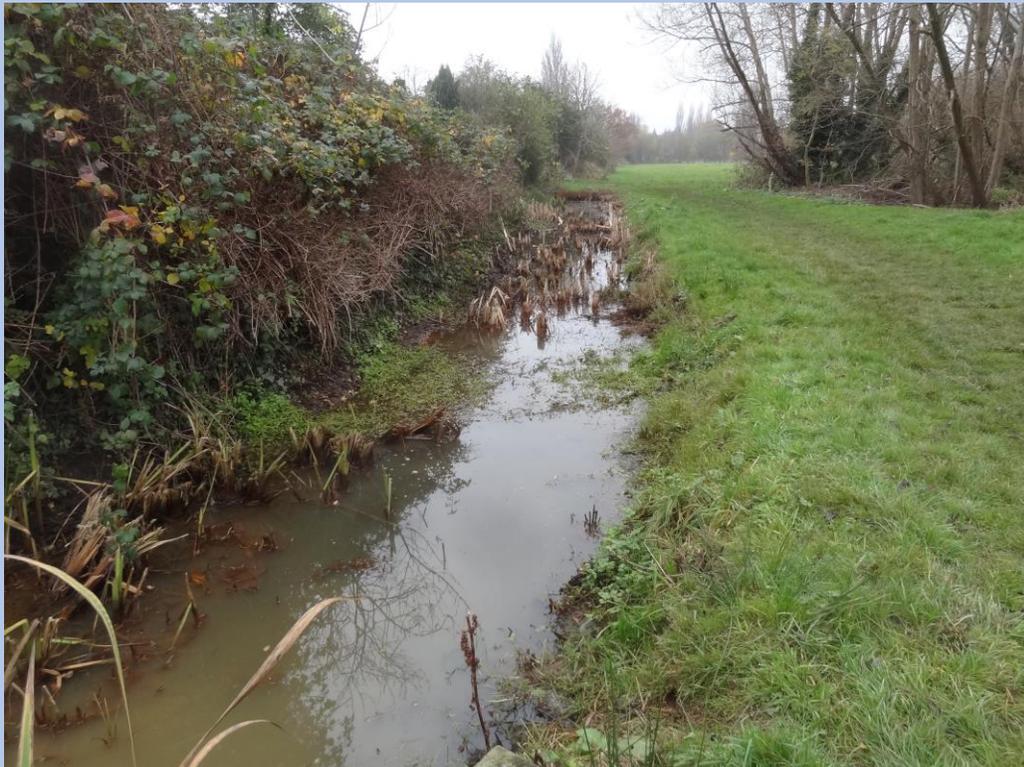
Brook Drive is aligned over a former water channel shown on pre-1930s OS maps. This drainage ditch (looking W) is alongside the northernmost property boundaries of the road, a cul-de-sac.

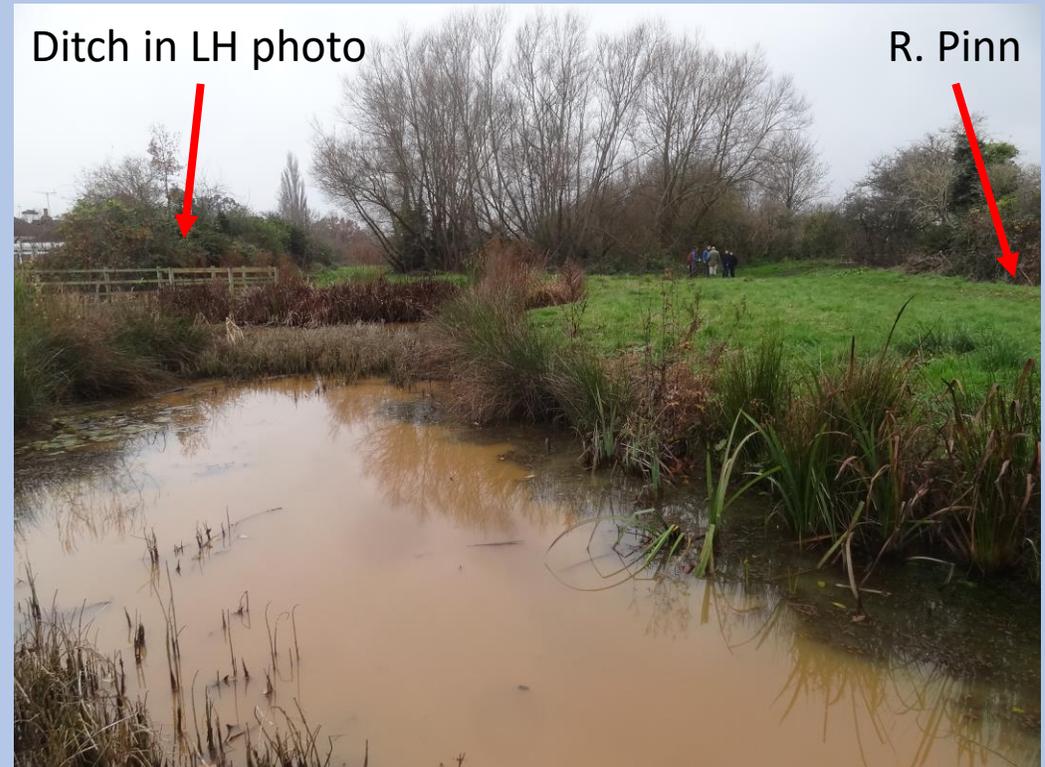
Recently made pond for excess water storage.
