## River Pinn & Ruislip Woods

# Flooding Issues – Does the Geology have an influence?

Report of a site meeting on  
24 November 2021

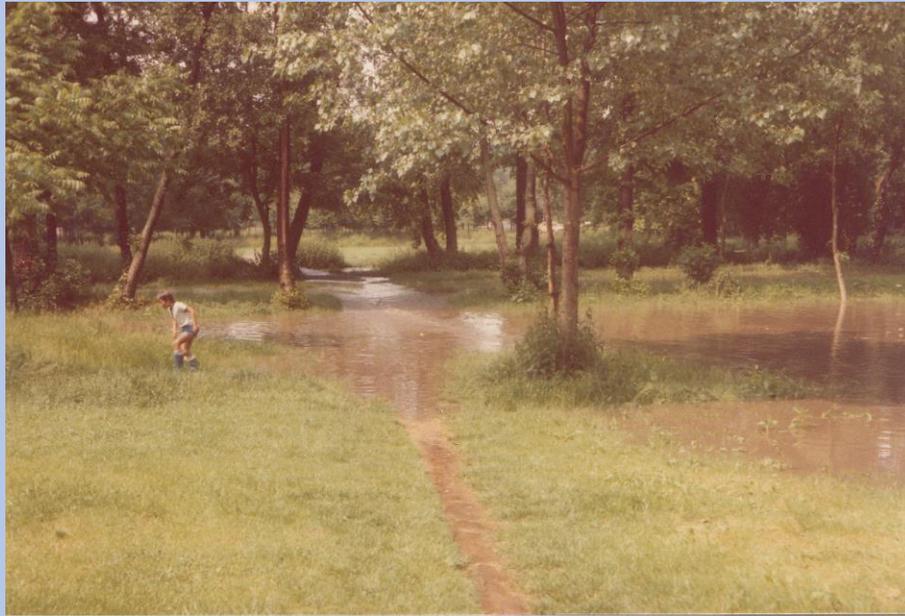
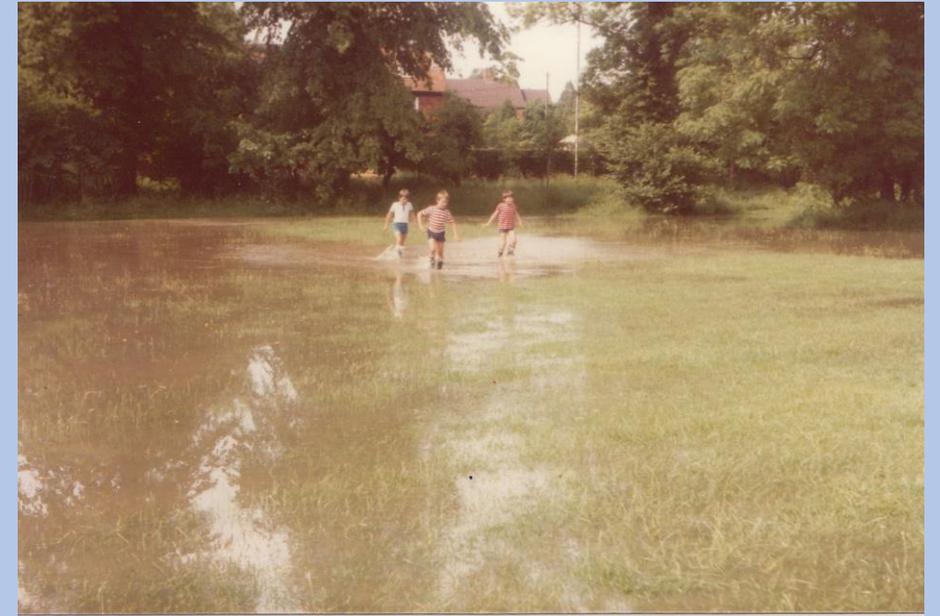
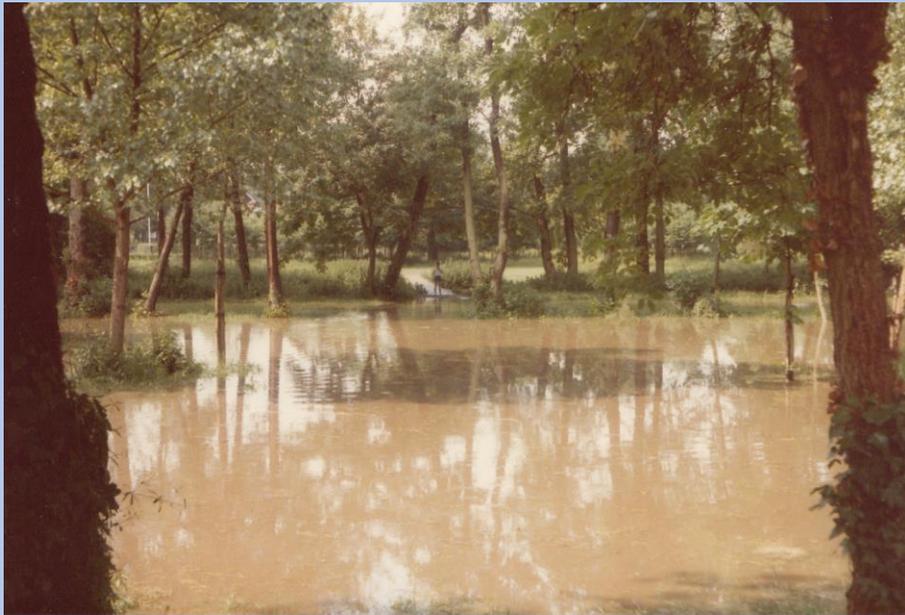
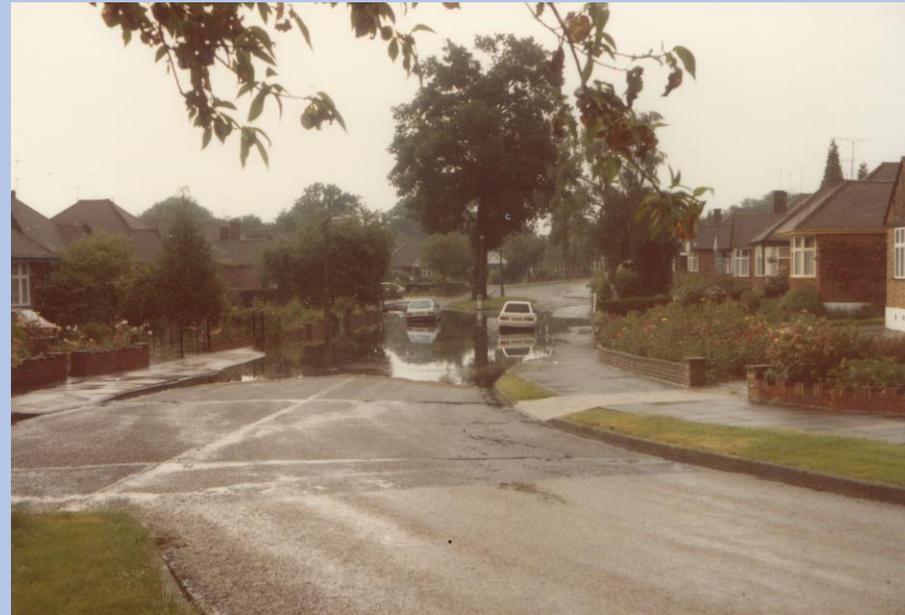
# Further examples: Eastcote, July 1984

Long Meadow  
near Eastcote  
House Gardens

Rodney  
Gardens

Bungalows nearest the  
Pinn have flood cellars

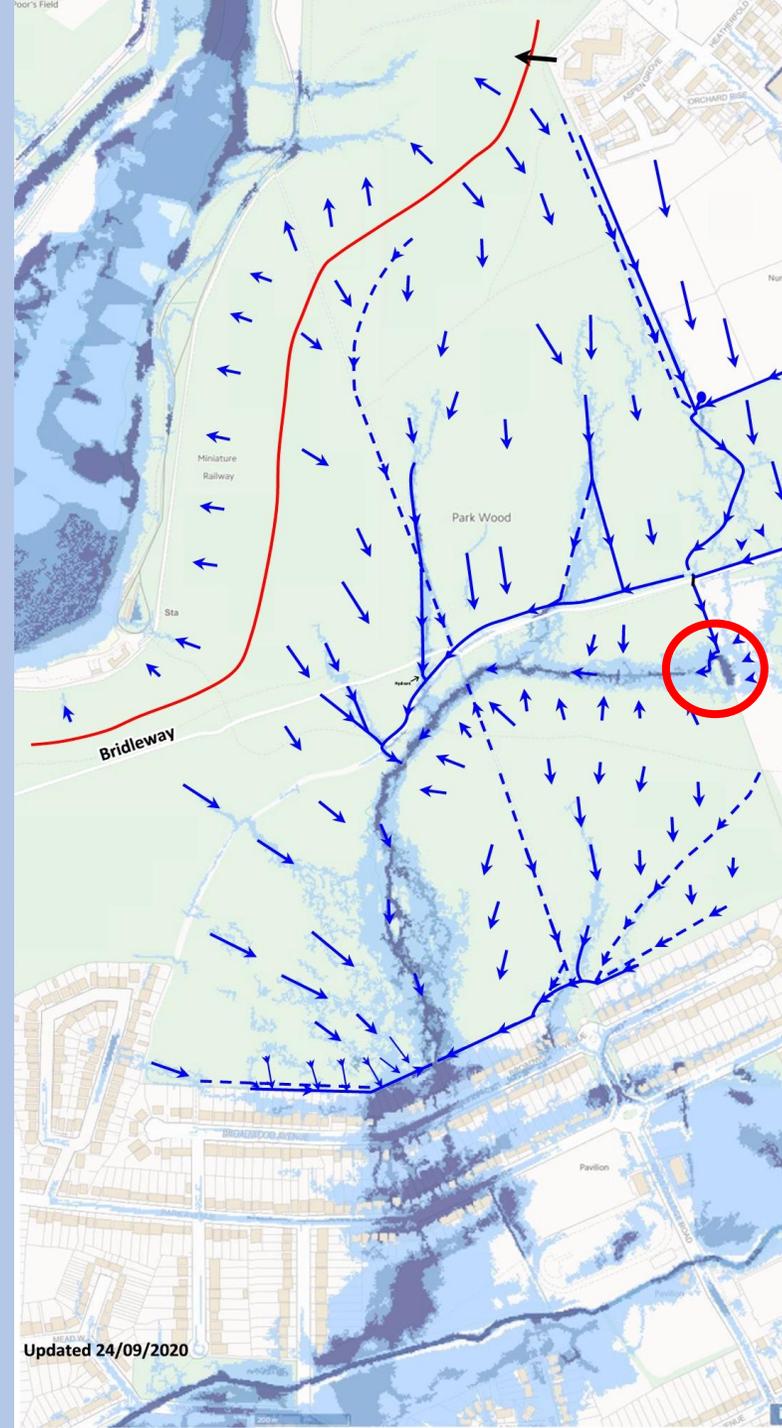
Grub Ground Pond

The Coppicers' Channel exits this pond which is probably fed by springs

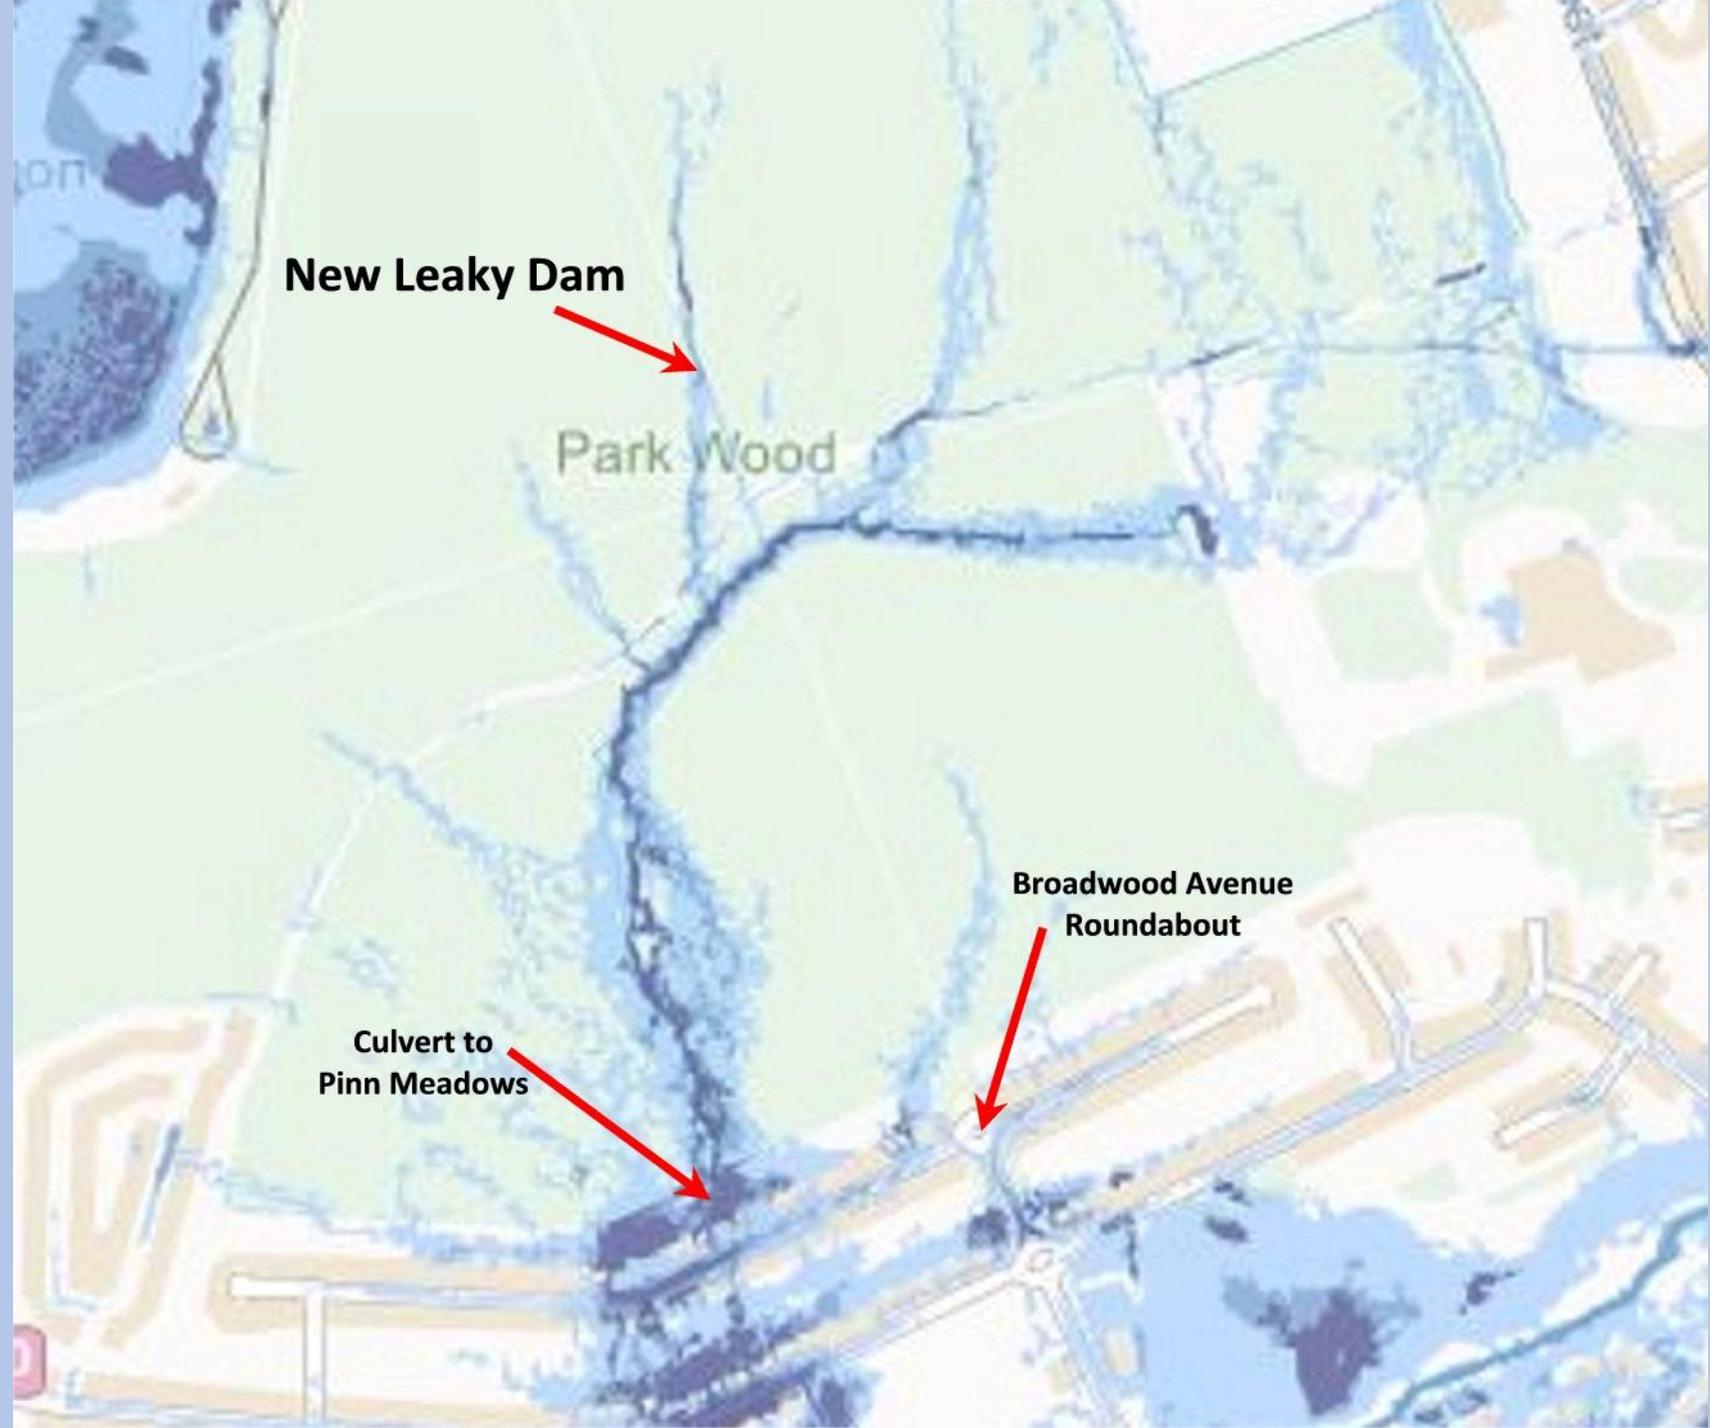
# Location of the leaky dam

It is one of 40 within  
Park Wood  
(as of January 2022)

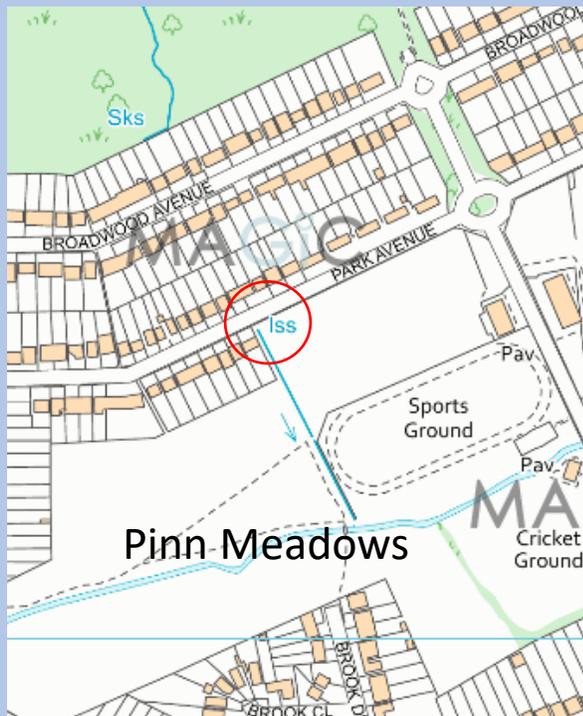
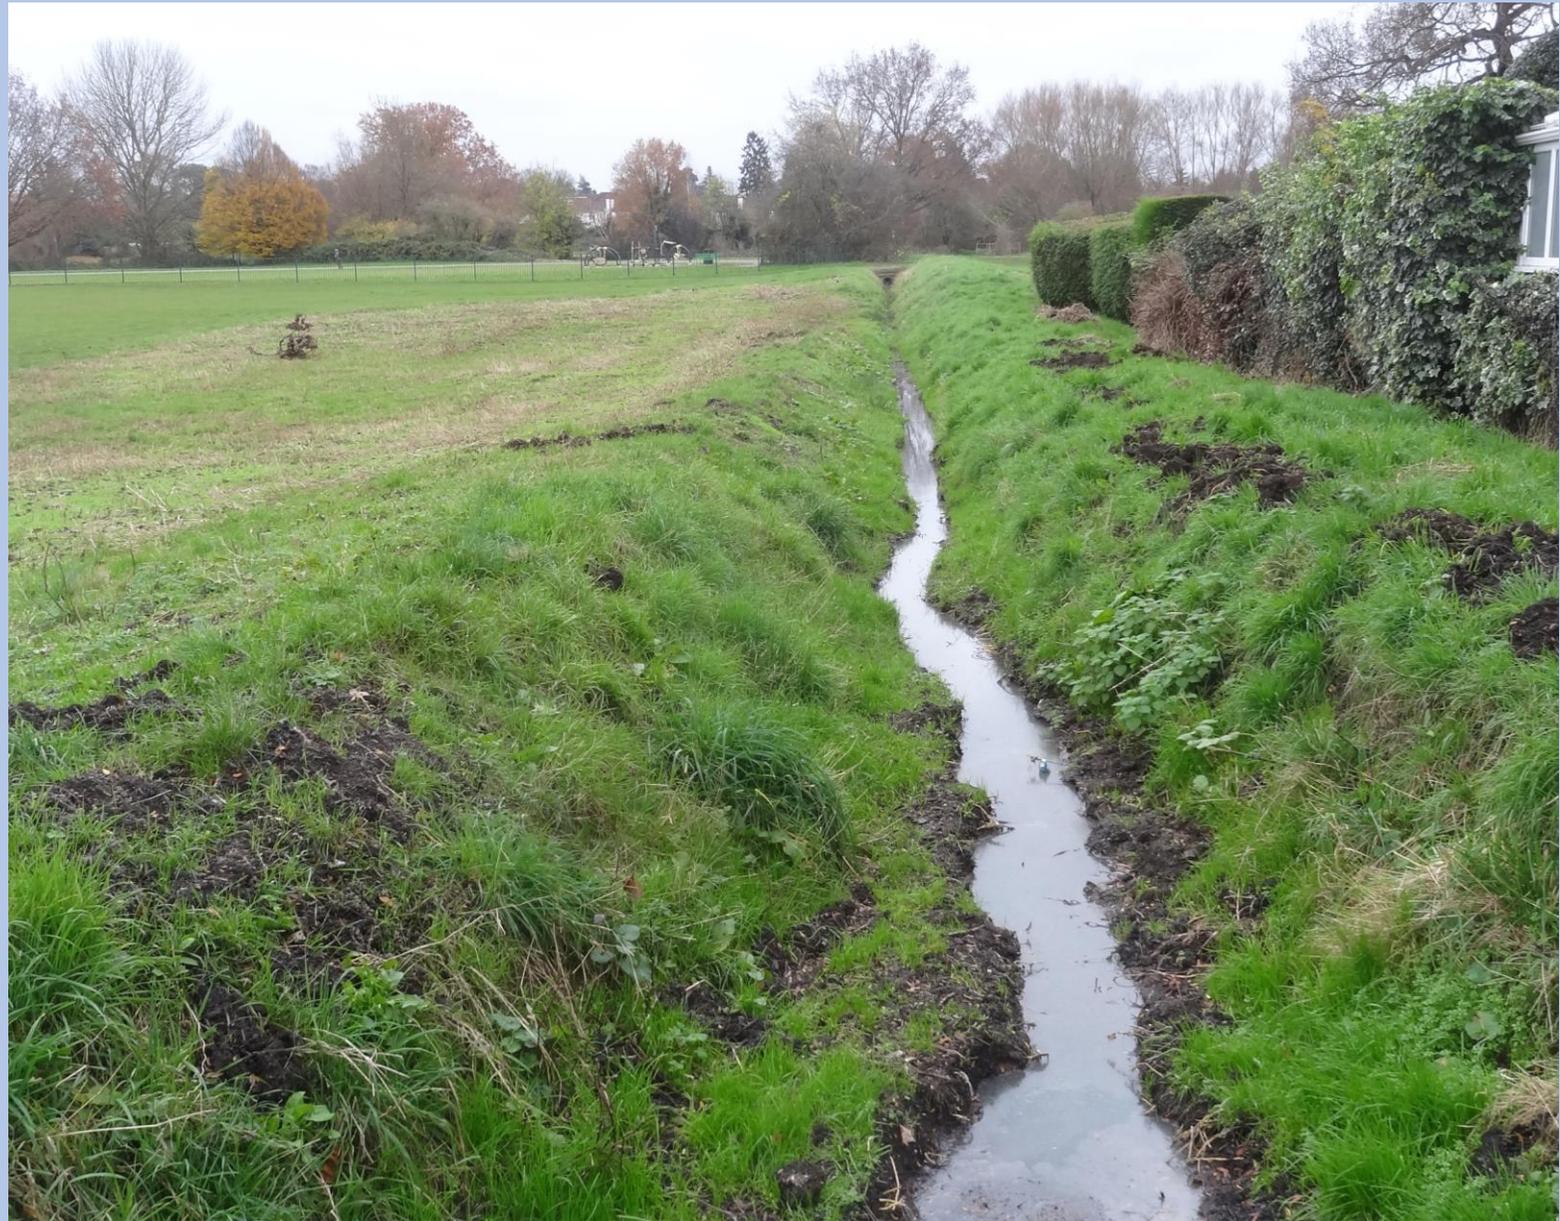
# Drainage ditch ('Elma's Ditch') carrying water from a culvert under Broadwood & Park Avenues

This is water draining from Park Wood and connects with the Coppicers' Channel. The picture location is marked as 'Iss' (issue) on the 1:10,000 OS map ('Sks' = 'Sinks').

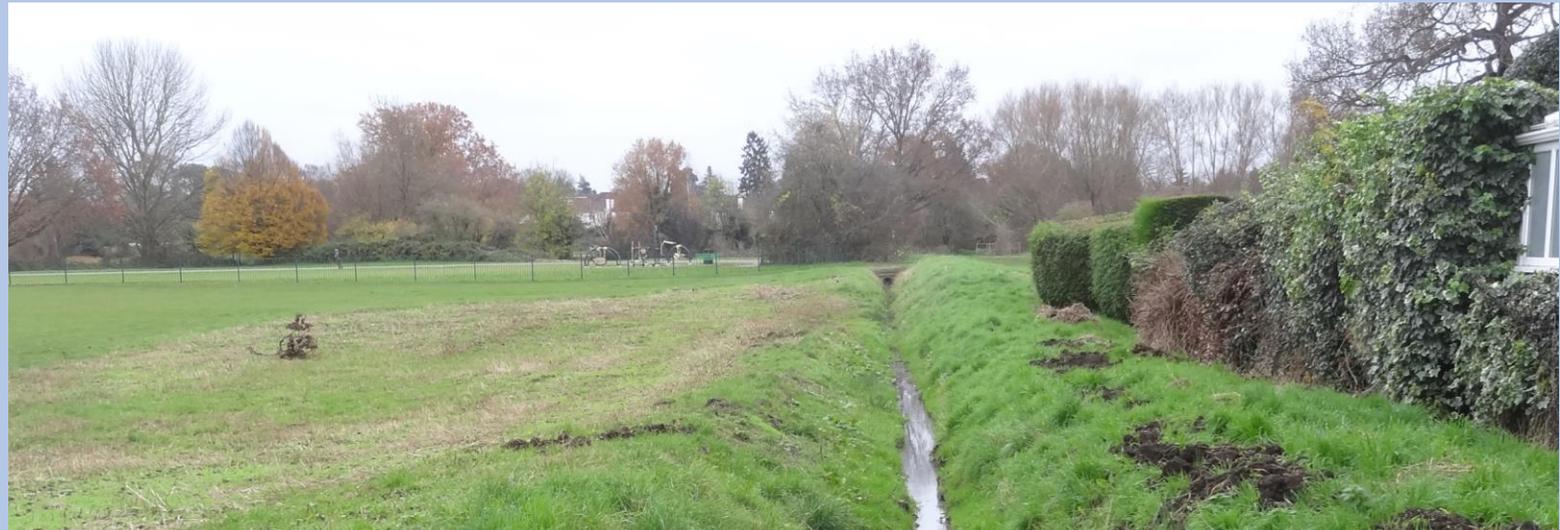
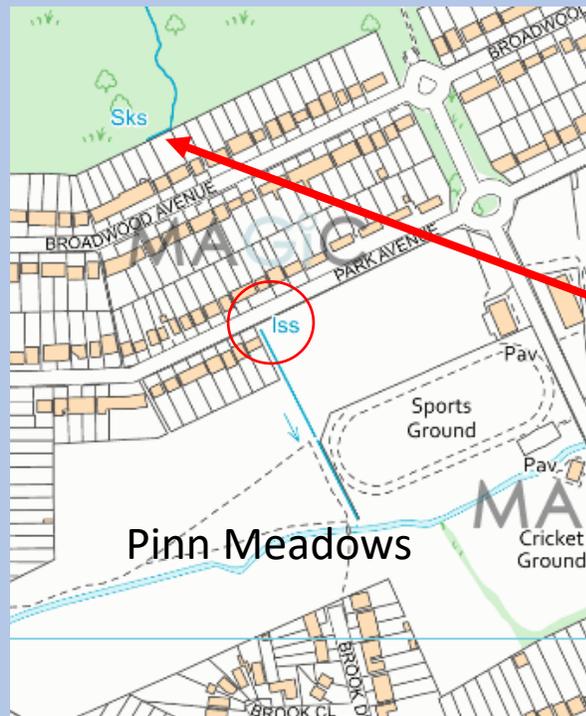
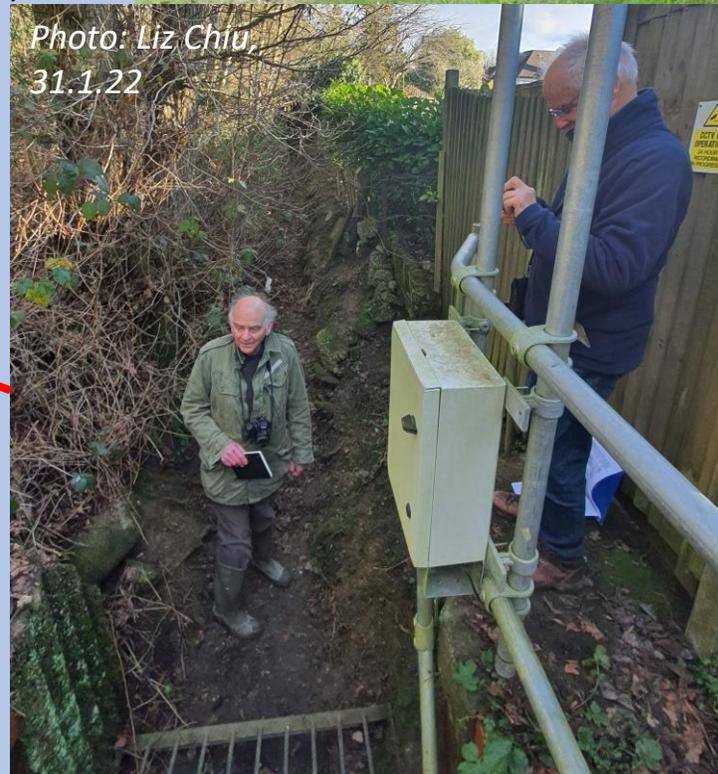
# Drainage ditch ('Elma's Ditch') carrying water from a culvert under Broadwood & Park Avenues

This is water draining from Park Wood and connects with the Coppicers' Channel. The picture location is marked as 'Iss' (issue) on the 1:10,000 OS map ('Sks' = 'Sinks').

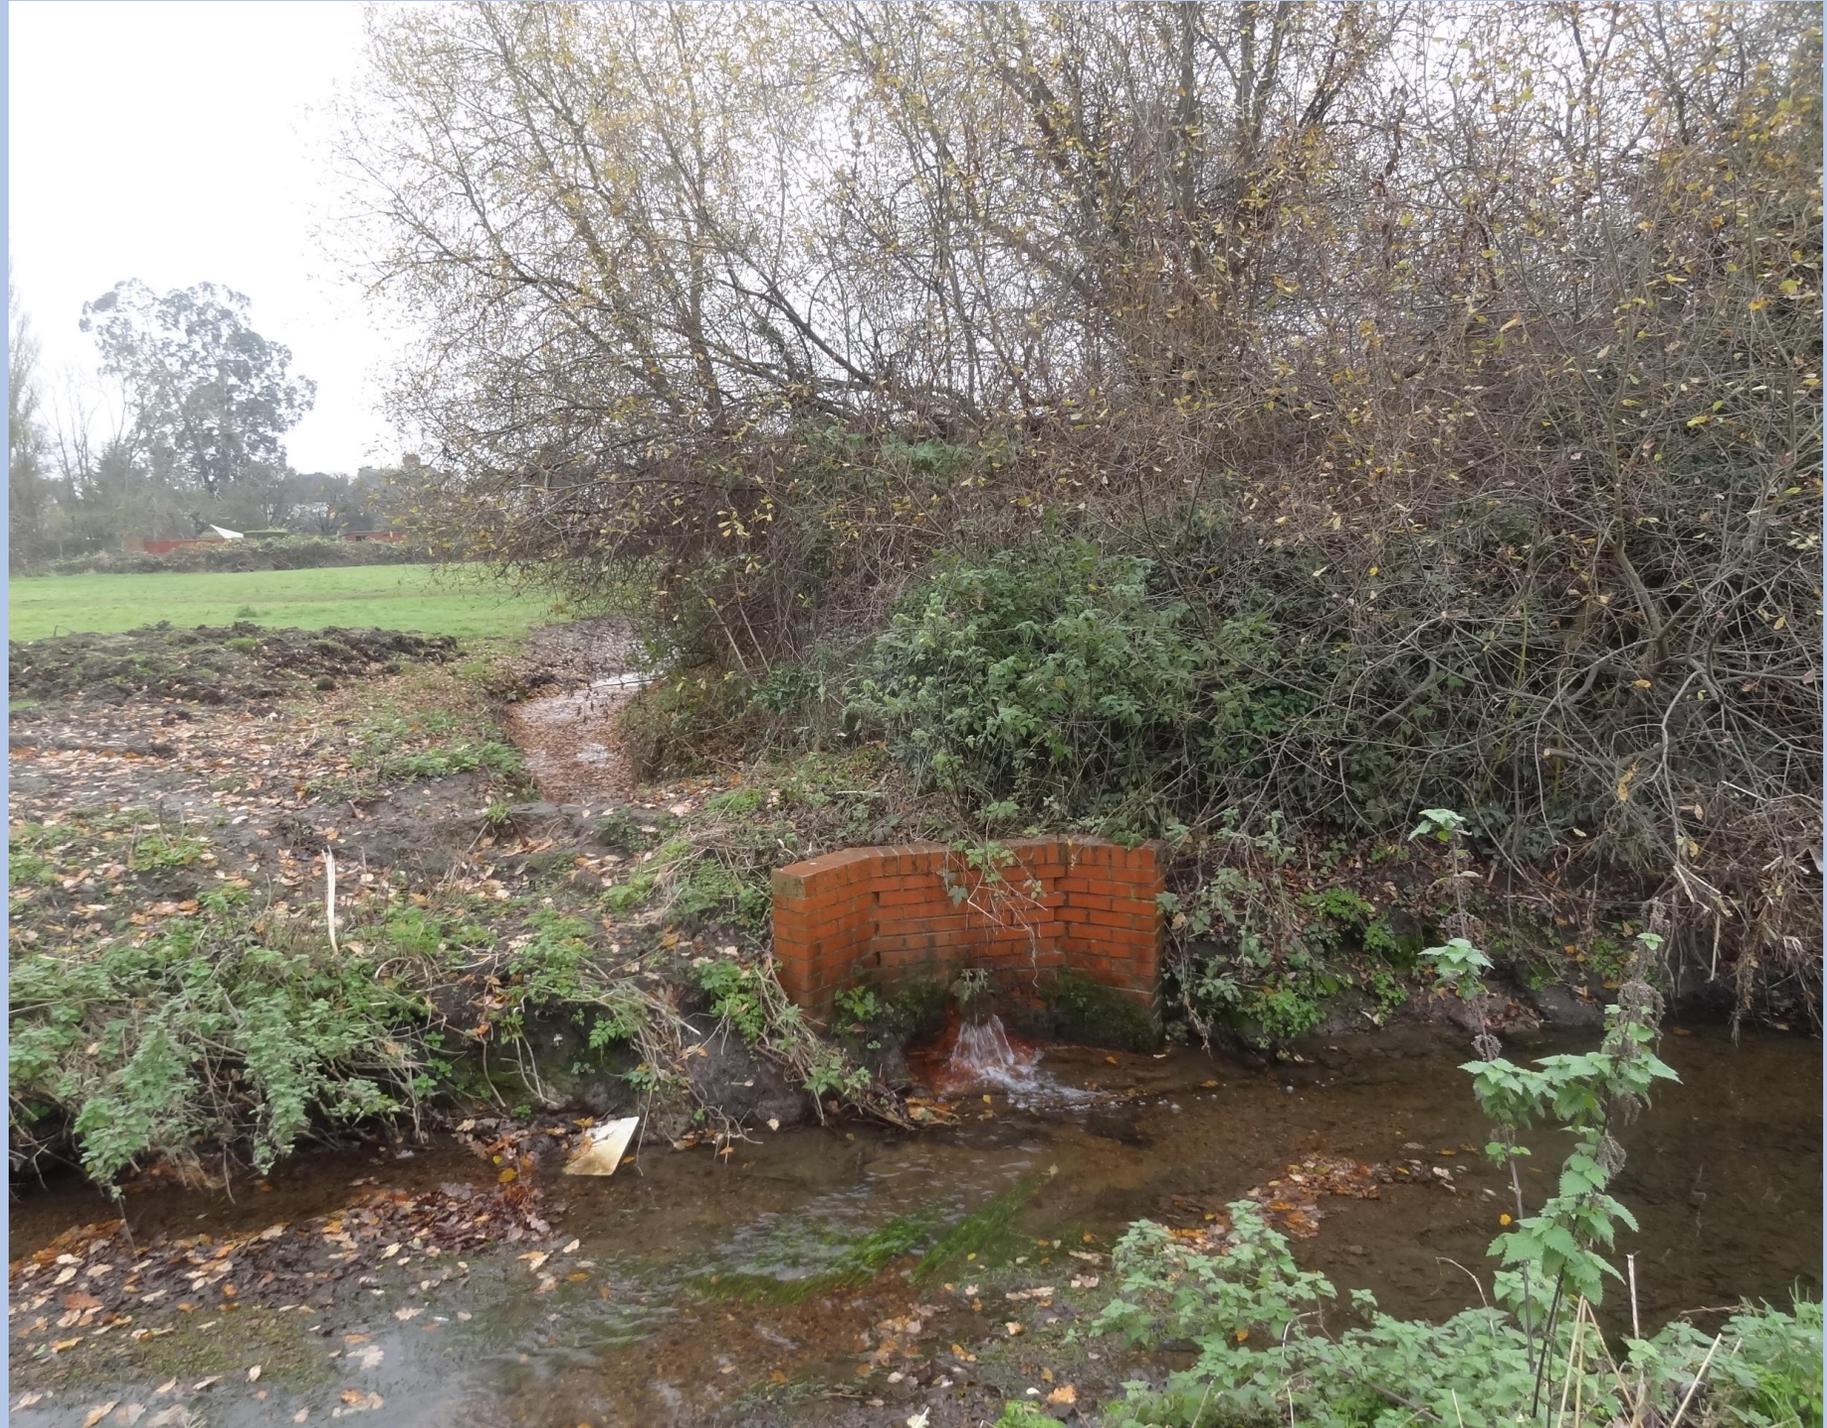
Watercourse shown  
on previous two  
slides discharging  
into the Pinn
